**AGREEMENT BETWEEN THE KENSINGTON POLICE PROTECTION  
AND COMMUNITY SERVICES DISTRICT AND THE KENSINGTON  
COMMUNITY COUNCIL REGARDING RECREATIONAL AND  
EDUCATIONAL PROGRAM SERVICES**

**3.1.** The District has obtained a report from Cantor Inspections dated April 26, 2023, that details conditions in the Recreation Building that require significant maintenance and repair (“Cantor Report”). A copy of the Cantor Report is set forth in Exhibit in E.

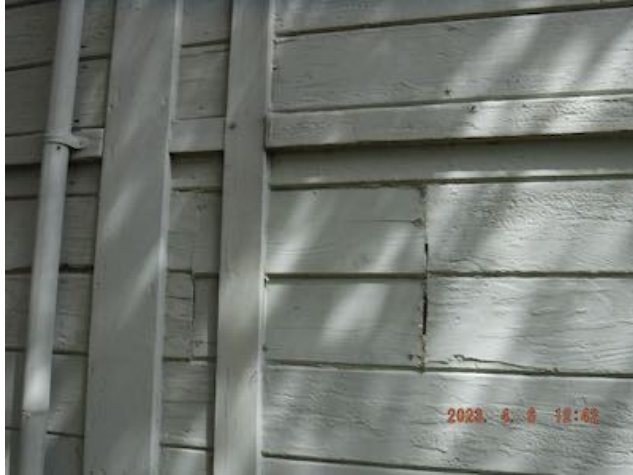
This building has horizontal wood siding. The siding shows moderate wear. Moderate damage was seen in a few places, but none was deemed significant. This was mostly in the form of improperly staggered cuts that are likely to have been access panels or poor repairs. See an example below.

We recommend that these areas be properly nailed and filled prior to painting.

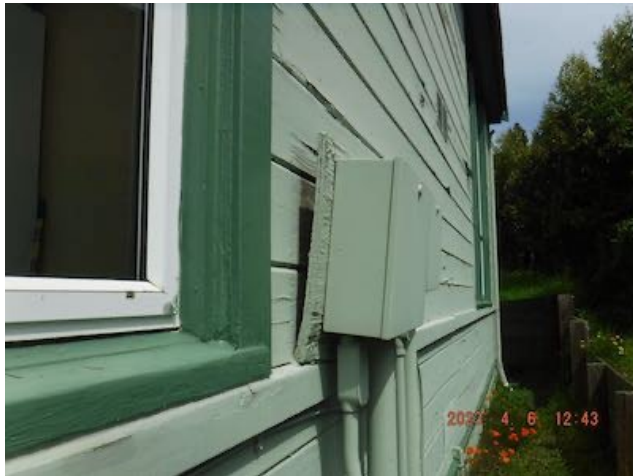
Low voltage electrical equipment is mounted on the left-hand side of the building using a plywood panel which has become loose from the siding.

This has only a very minor effect on the building itself and should be referred to the installer or maintenance parties related to the low voltage equipment.

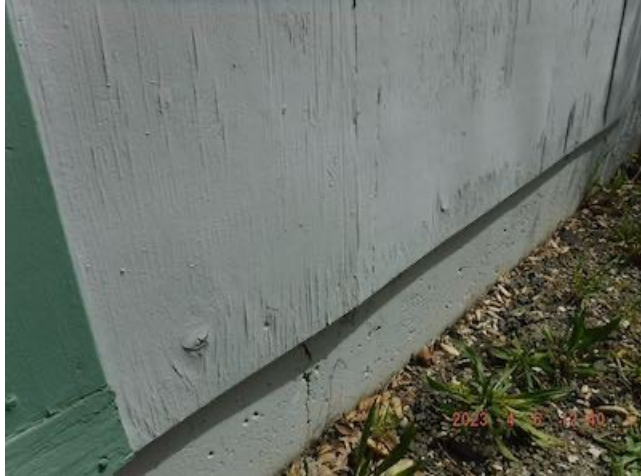
There is plywood siding at the building skirt, mostly at the rear. This siding shows moderate wear with some localized damage. See this below.

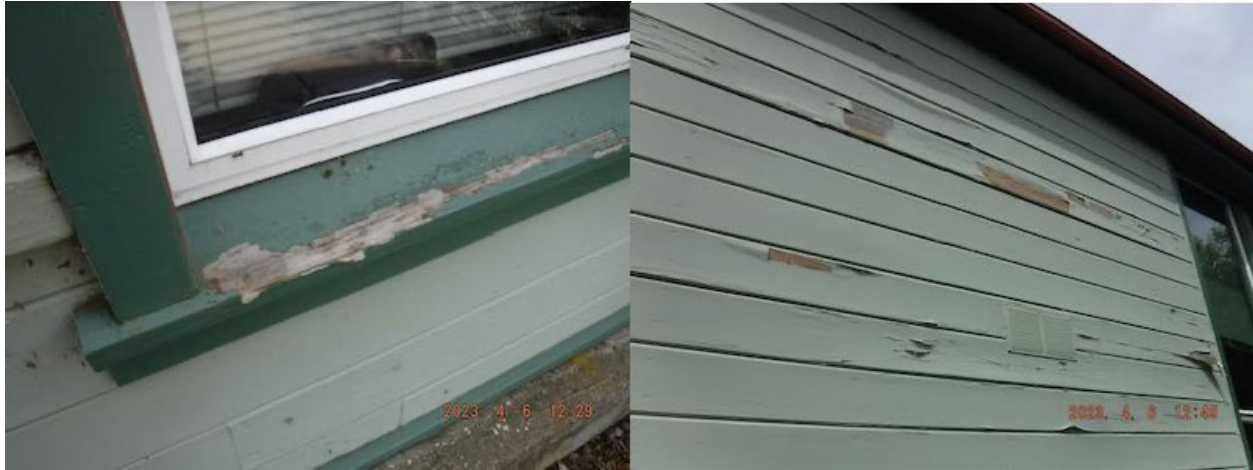
The paint is peeling on the siding and trim in several places. We recommend the peeling paint be scraped, sanded, caulked, primed, and painted as needed by a qualified painting contractor.

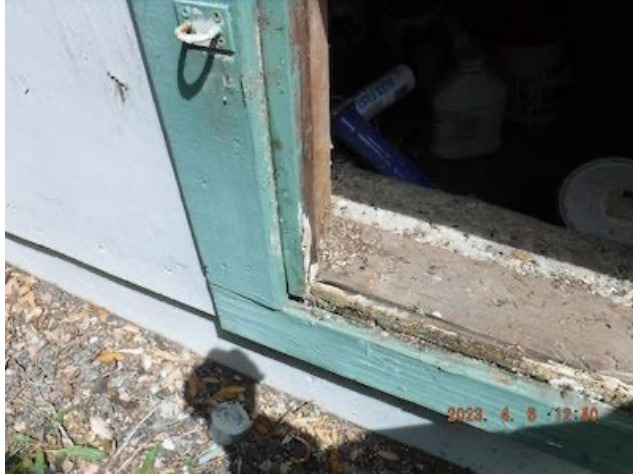
The trim is damaged in a few places. See some of this, below, around one of the two crawlspace openings at the rear.

We recommend the damaged trim be repaired or replaced as needed. None of this was highly critical.

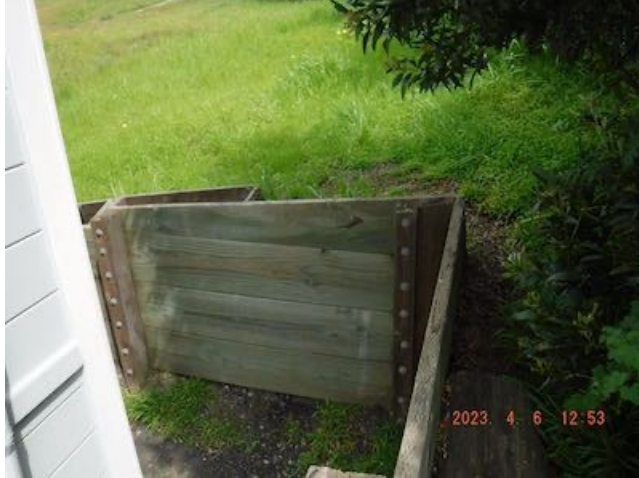
There are wooden retaining walls at the front/right. These walls are not provided with sufficient barriers or guardrails to prevent a fall. See below.

We recommend adequate safety barriers be installed.

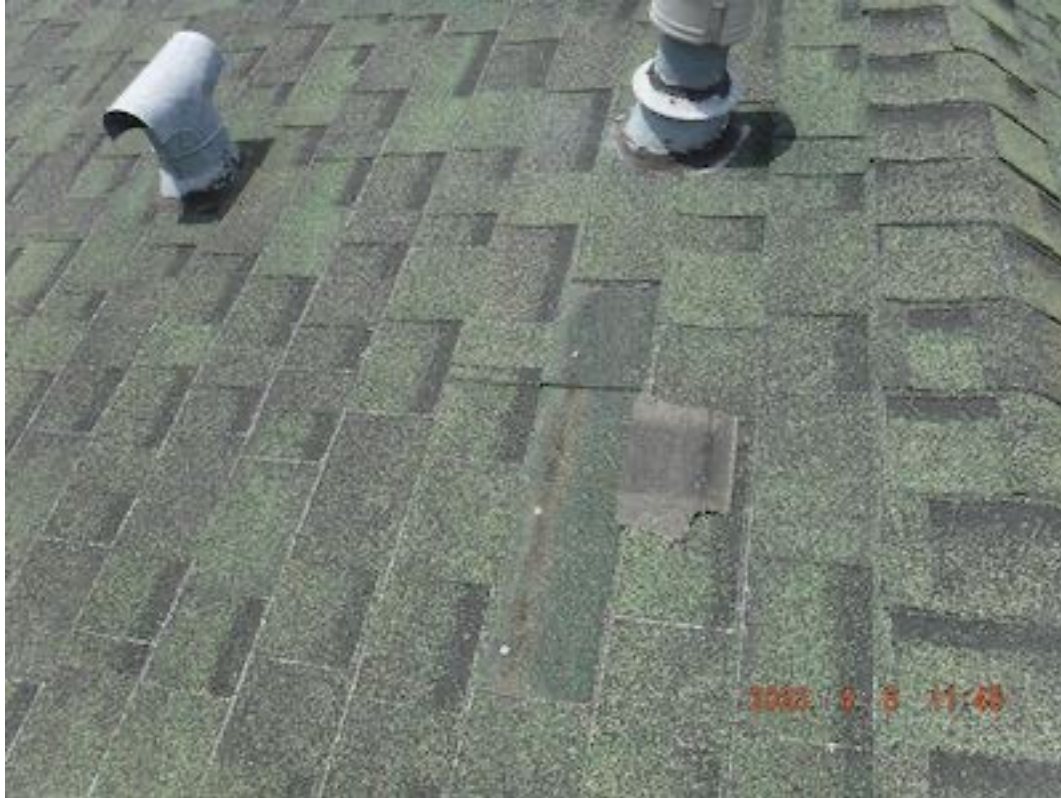
The building has a laminated composition shingle roof, which is in very worn condition and damaged in several places. See the damage below.

There are several exposed fasteners. With time exposed fasteners will rust and loosen and may cause leakage.

The roofing shows evidence of numerous repairs and has been extensively patched in several places, likely indicating previous roof leakage.

We recommend a new roof surface be installed.

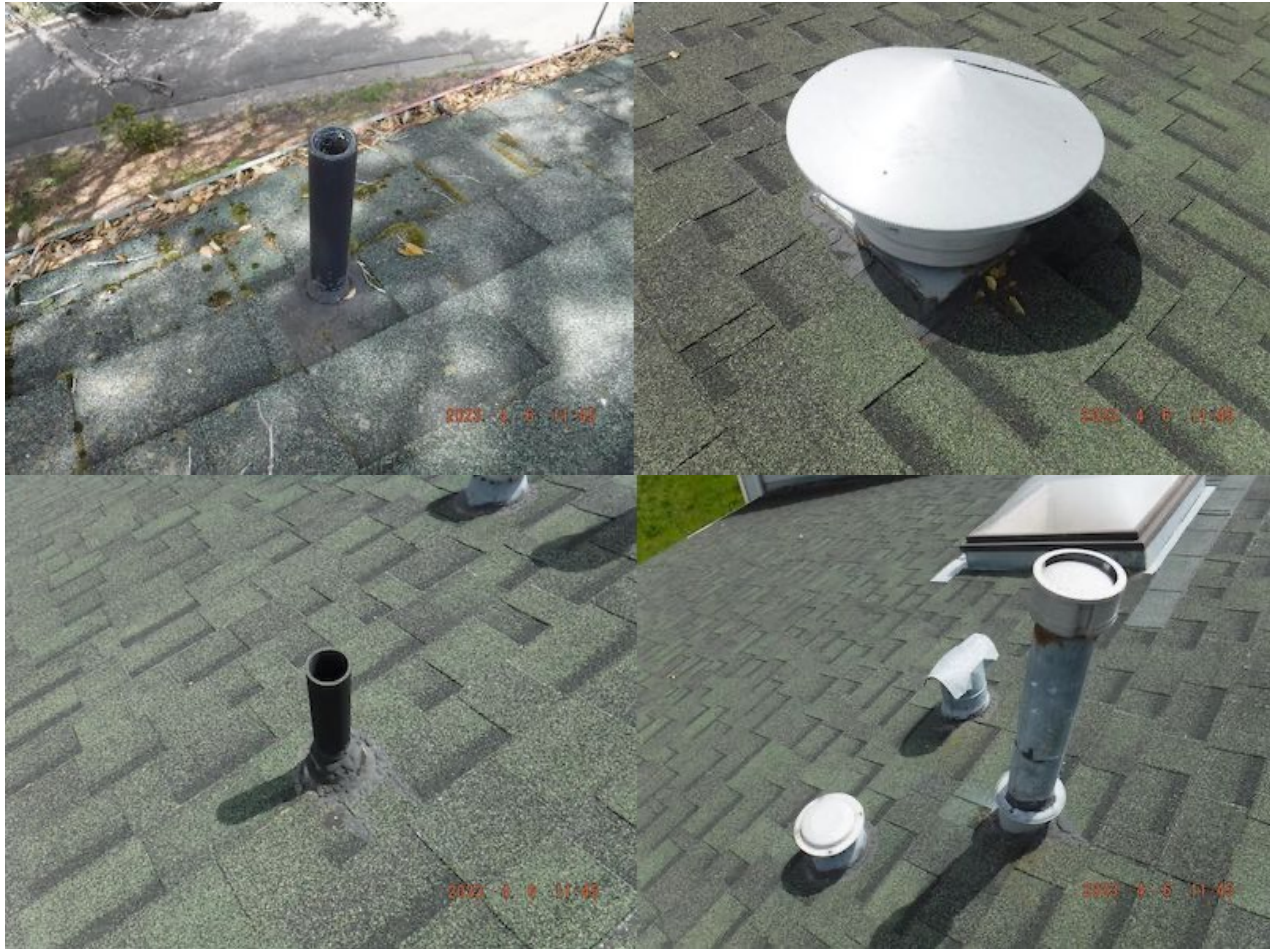
Several of the piping penetrations lack proper flashings and rely upon mastic predominately. See below.

We recommend that all of the flashings be replaced with the new roof.

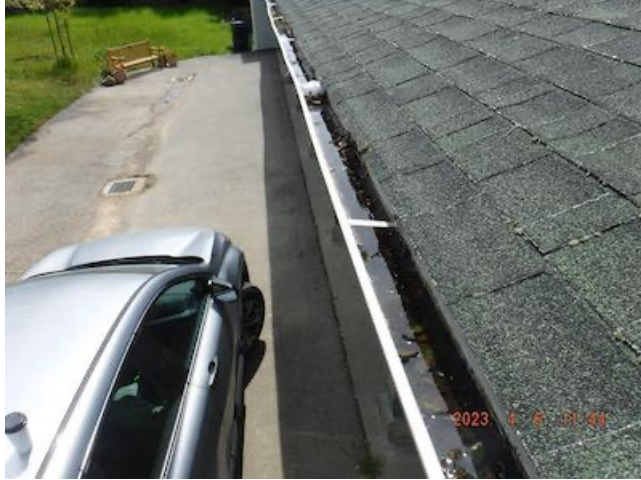
Debris has accumulated densely in several places in the gutters. There are signs of previous standing water in several places.

We recommend the gutters be cleaned and re-examined, and modified as needed to drain freely. Rain gutters should be cleared periodically as part of routine maintenance.

We recommend strainers be installed in the gutters to minimize clogging by debris.

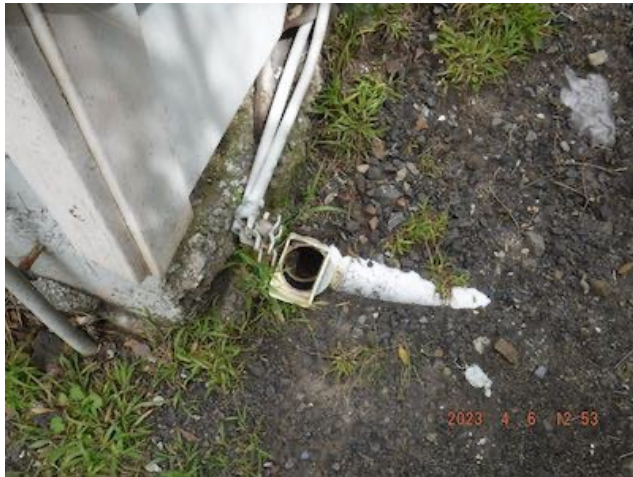
Several downspouts are disconnected at the top or bottom and we recommend repair.

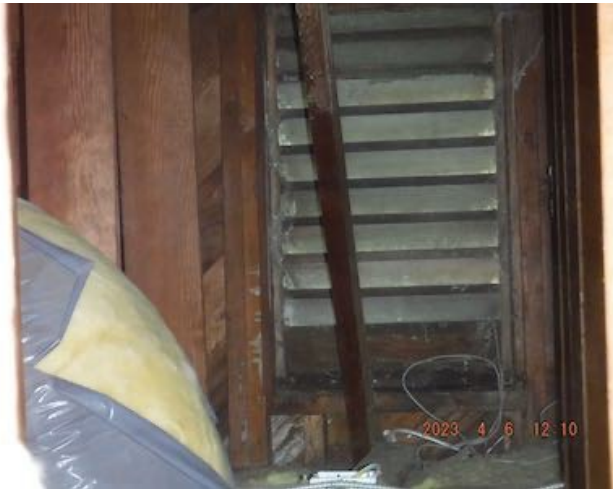
Several attic vents are not screened.

We recommend the vents be screened to prevent animal entry.

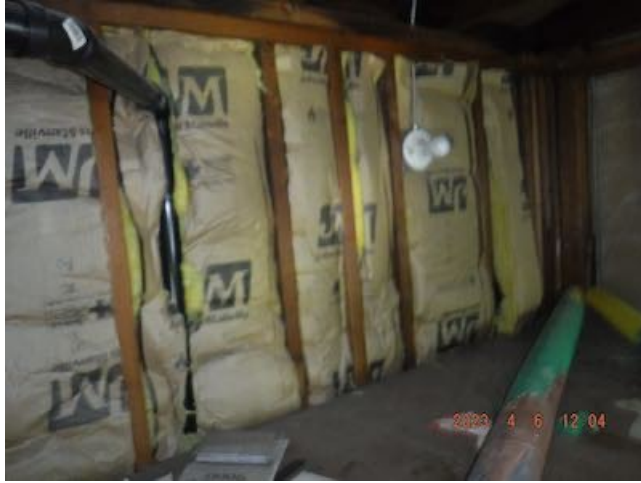
The insulation in the attic vestibules near the furnace has been installed reversed with the paper backing facing the open space. See an example below.

Inverted vapor barriers can constitute a fire hazard. A warning to this effect is typically found on the insulation vapor barrier. The vapor barrier should be placed against a solid backing, toward the interior of the dwelling and should never be visible from the crawlspace or the attic. In humid environments, this inversion can also cause the accrual of condensation and can damage framing. We recommend vapor barriers be properly placed.

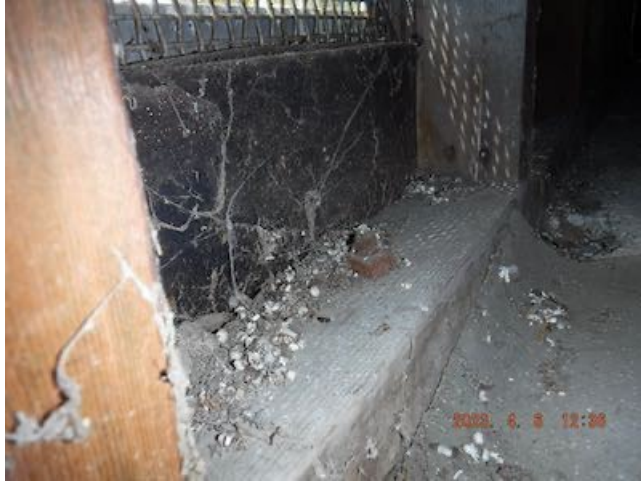
The foundation is equipped with a few, small, rusty anchor bolts. See one below.

As a rule, foundation bolts installed in most of the 20th century fall short of the strength mandated by engineers when seismic retrofitting is done. Currently engineers will typically call for a larger number of bolts (more per linear foot of foundation), larger bolts, improved washers and well tightened bolting. It is also clear that rusting of non-galvanized bolting, which is the kind used in nearly all foundations, leads to weakening over just a few decades and they can lose much of their strength after many decades. Older bolts should be replaced by new, improved bolting in all houses located near major fault lines.

We recommend additional anchor bolts be installed as needed by a qualified contractor.

We recommend a qualified engineer be retained to design or specify seismic upgrades appropriate for this building.

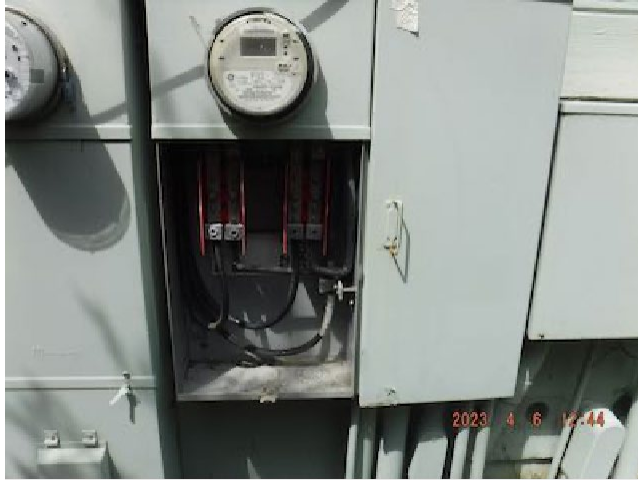
One of the panels in this main service assembly is not designed to be open by users and contains exposed hot terminals that could kill if opened by nonprofessionals. We urge that this panel be repaired for security immediately. See this below.

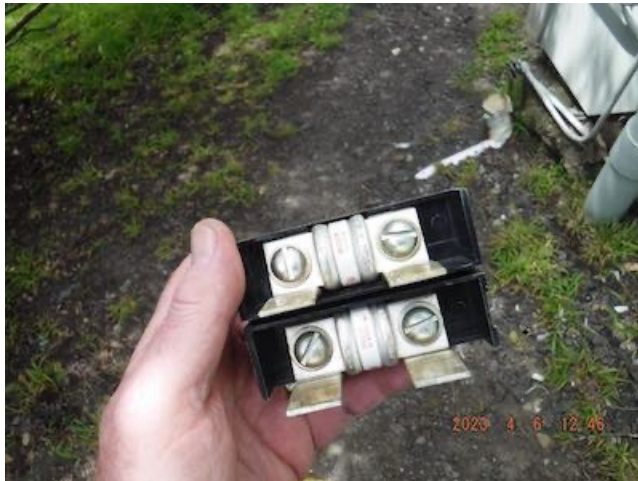
There is both a breaker main panel and a fuse main panel at the left exterior. Fuses in the latter panel are used for high voltage protection, as opposed the more outdated fuses of panels from the 1940 and earlier. The use of fuses (T type 200 amp shown below) in this case is not a concern for us, though more modern equipment will generally use solely breakers and add convenience.

The assembly of panels is damaged in several places, and we recommend repair or replacement by a qualified electrician. The panels also appear to be worn past a reasonable point of repair and maintenance and we suggest replacement of the entire assembly.

The left panel is in very worn condition, damaged in several places, and will soon need replacement. We recommend the left main panel be repaired or replaced by a qualified electrician.

The right fuse panel is very rusty and we recommend it be replaced.

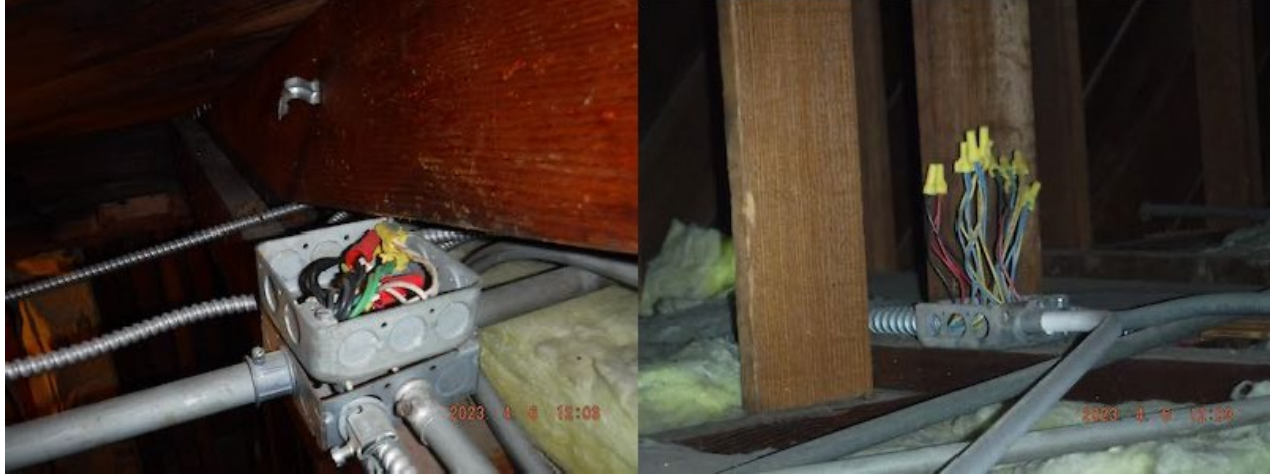
Several attic area electrical boxes are uncovered. We recommend box covers be installed as needed in the subfloor area. See two below.

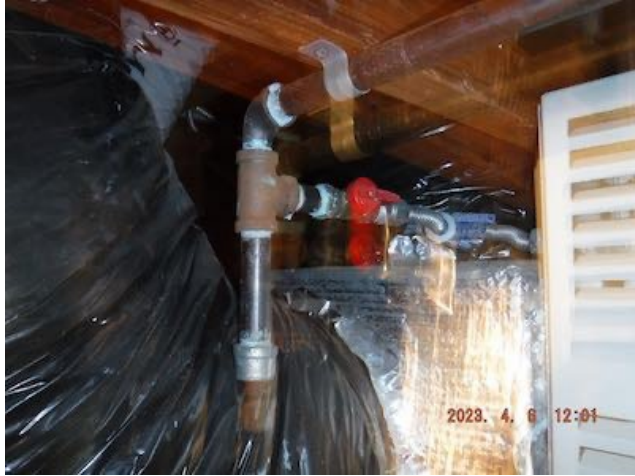
The sediment trap is installed before the gas valve instead of after and we recommend it be properly installed. This helps to deliver dry gas and prevent gas appliance failure. See this below.

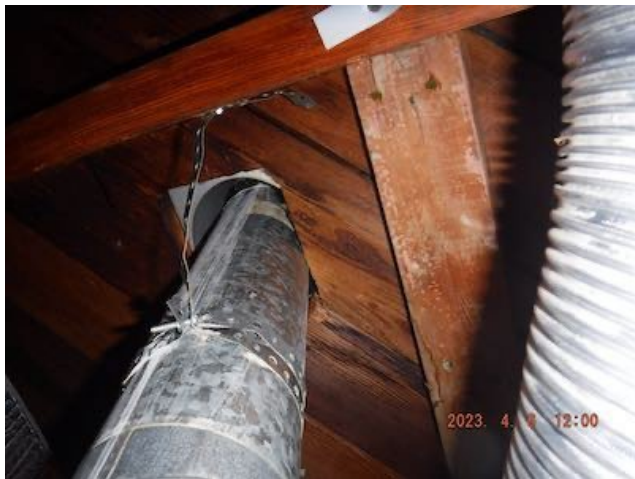
The double-wall vent piping is too close to roof sheathing and insulation, which is a potential fire hazard. See below.

We recommend adequate vent pipe clearance be provided. Double-wall vent pipes need at least 1-inch clearance from combustibles.

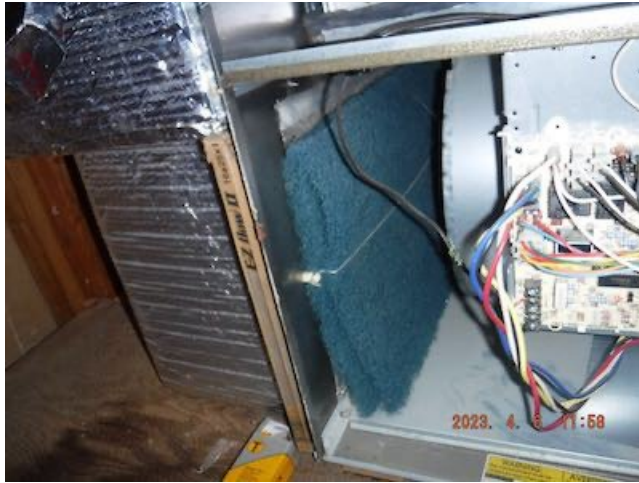
There is also a separate filter to the left of the unit and this lacks a proper filter cover as required. We recommend that a proper filter cover be installed by a qualified heating contractor.

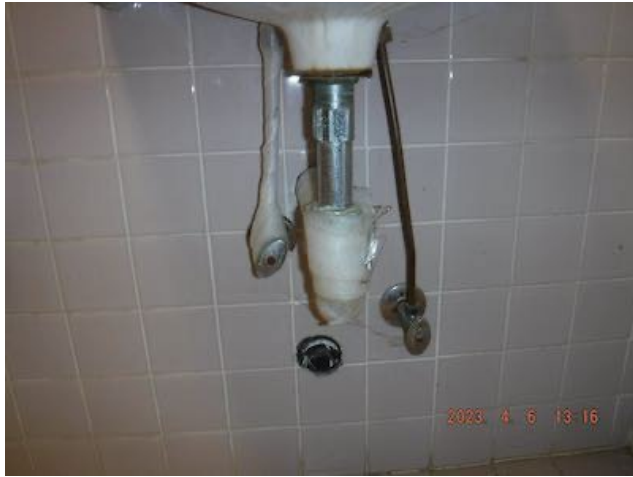
The ADA sink protection is incomplete in this bath. This can allow for scalding of some individuals and we recommend review of this and all related ADA issues with a qualified expert/contractor. See below.

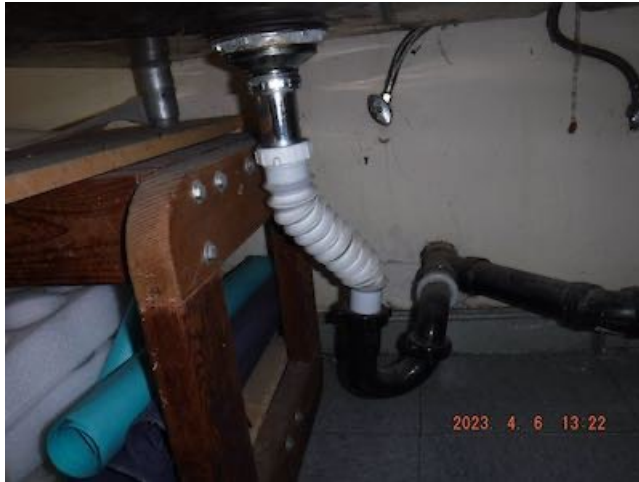
There is a stainless steel art sink in the main room at the rear. Flexible plastic waste piping is used at the sink drain and we recommend it be replaced with proper, smooth wall drain piping.
