Date: July 13, 2023
To: Board of Directors
From: David Aranda, Interim General Manager
Subject: Discussion Regarding Park Facilities, Improvements and Protection

CANTOR INSPECTIONS

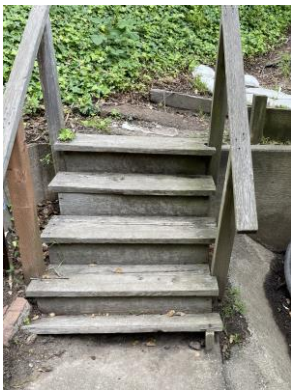
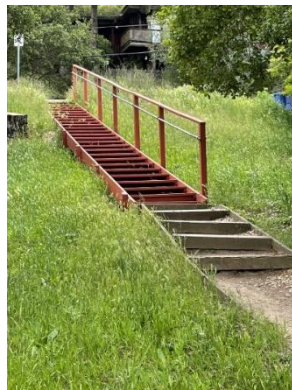
The park has a combination of unpaved trails, paved walkways, and stairways. It was noted that some stairways and paved walkways were well maintained, however, there were also stairways with worn planks, loose rails, and uneven steps, and raised cracks. The small stairway on the side of the community center is accessible to the public; however, the stairway leads to a path that has a drop and is unsafe.

- Consider utilizing an ADA Certified Access Specialist to evaluate the District's compliance with ADA requirements for parking lots, the Community Center, amphitheater, and general access.
- Develop an inspection process to identify maintenance and repair requirements.

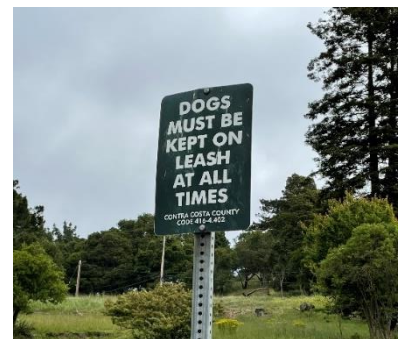
Dog Leash Requirements

Based on feedback from the District, it's a common practice for dog owners to allow their dogs to go unleashed on a regular basis. The District is considering developing a fenced dog park. An SDRMA Risk Advisory is available on Dog park risk management.

- Enforce the Contra Costa County leash requirements, as noted on the parks signs.

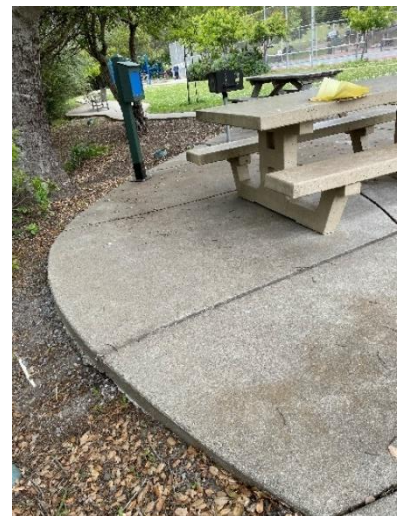
Picnic Areas

One of the designated picnic areas is located near a significant land drop. This could pose a fall exposure.

- Consider installing a barrier to assist in preventing a fall down the hill.

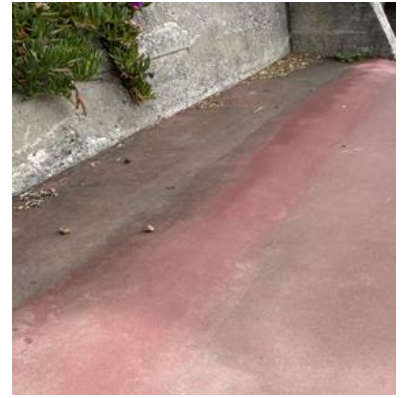
The hump inside the tennis courts could pose a fall risk when visitors are actively playing tennis. When playing tennis, the player is typically focused on hitting the ball and is not generally looking at the court surface.

- Consider determining why the hump is there and consider other solutions so the court surface is flat.

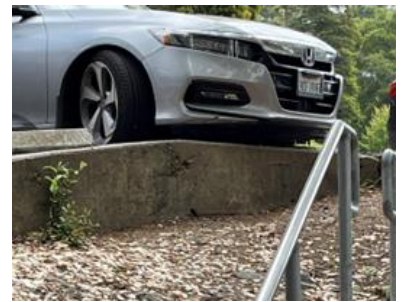
Parking Space

One of the parking spaces along an incline does not have a parking block or curb, which would allow a driver to drive forward over the hill and onto a stairway.

- Provide a parking block for this space and assess other parking spaces for similar exposures.

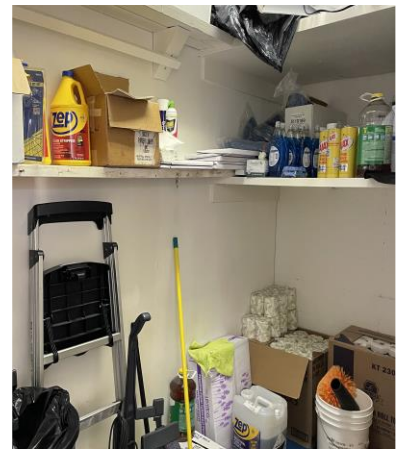
Community Center - Janitorial Supplies

The District has indicated the janitorial supplies are kept locked and used by the contractor. They are not available to the public.

- Ensure the contractor has required Safety Data Sheets for the hazardous materials utilized in the event of an exposure.

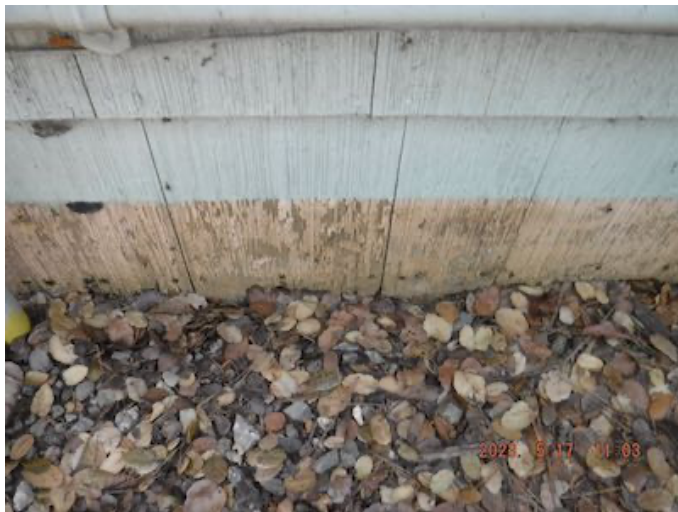
Wood siding in several places is embedded in the soil below. See below.

This condition can trap moisture in the wood and is conducive to decay. We recommend adequate clearance be provided as needed to eliminate embedded conditions.

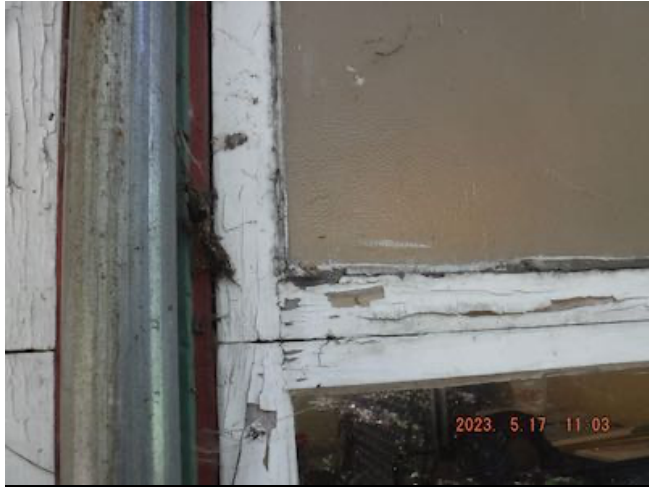
The exterior glazing putty is worn and missing in several places. We recommend new putty be installed as needed to protect the windows from moisture intrusion.

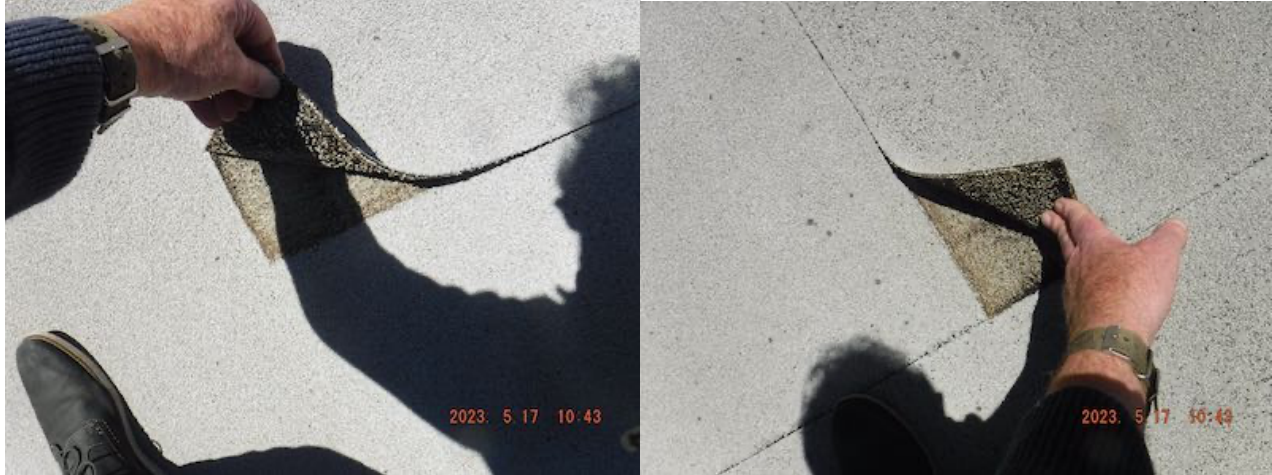
Several of the seams are not properly welded together. See two of these below.

This may be an adhesive type of modified bitumen and normal without the typical adhering bead resulting for adequate heating.

The roofing is loose in several places, and we recommend repair by a qualified roofer.

We recommend further inspection by a qualified roofer to determine the appropriate method of repair.

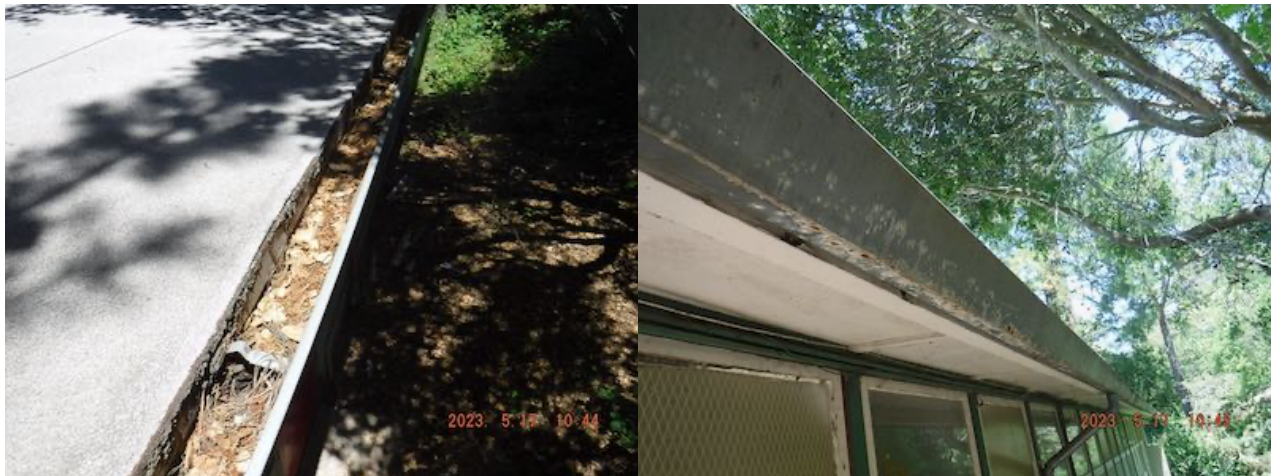
The roof has sheet metal rain gutters. They are in poor condition. We recommend the gutters be replaced. See below.

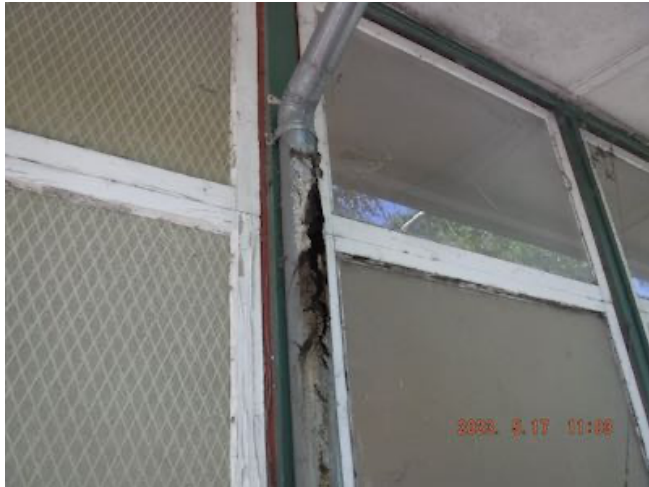
Several downspouts are damaged. See one below. We recommend all of the downspouts be replaced.

We recommend rain gutter downspouts be directed into subsurface drain lines.

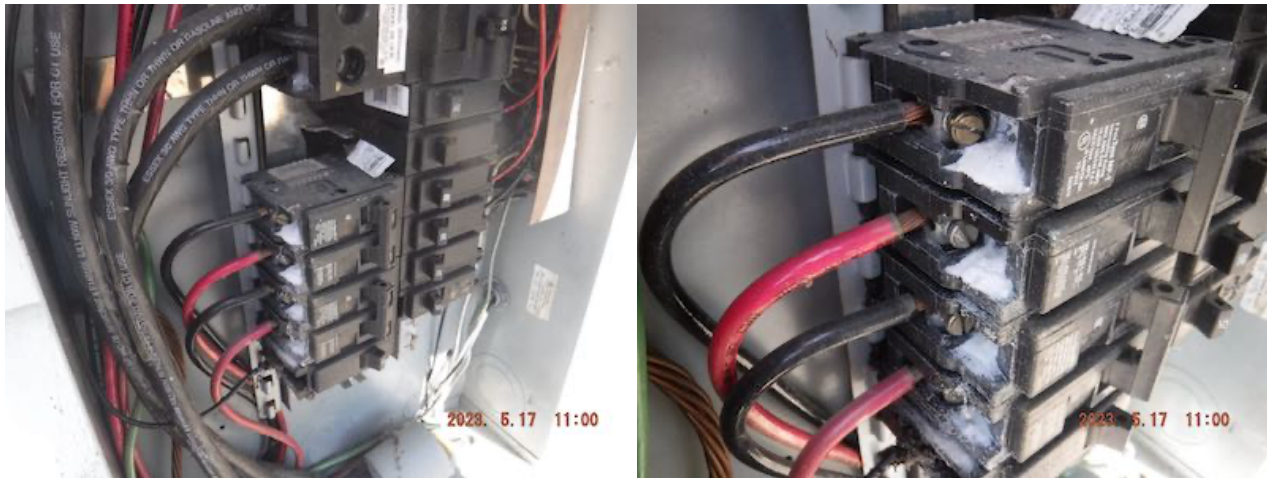
There is corrosion and built-up precipitate along the left side breakers, and we recommend repair or replacement by a qualified electrician. See this below.

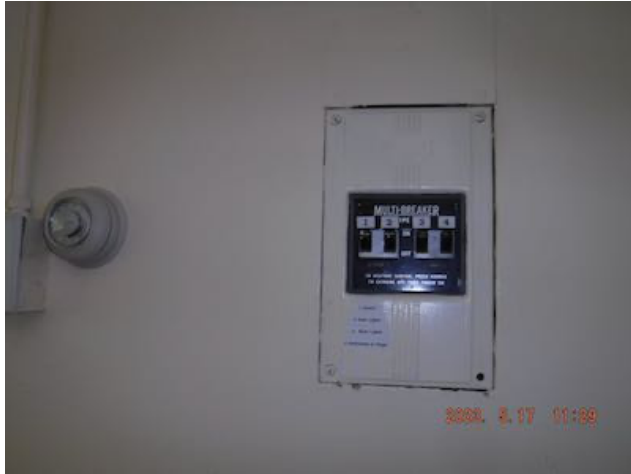
There are extremely outdated circuit breaker panels on the right and middle walls and we recommend these panels be replaced now. One is shown below.

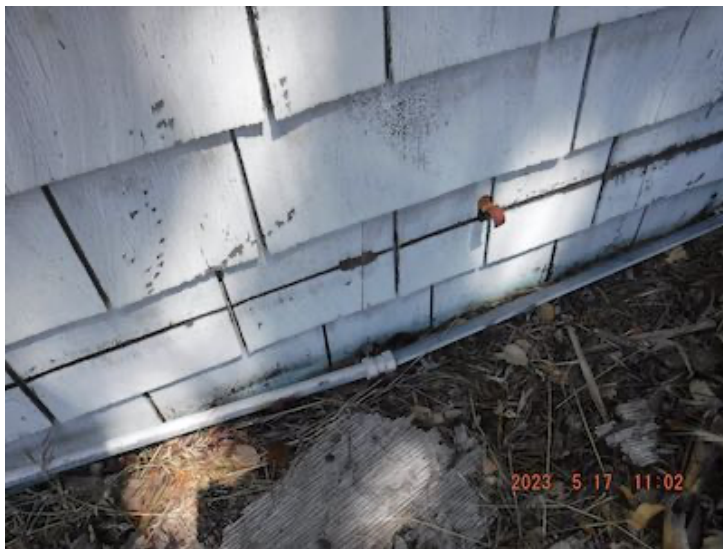
There is loose conduit in several places, and we recommend this wiring be repaired or replaced.

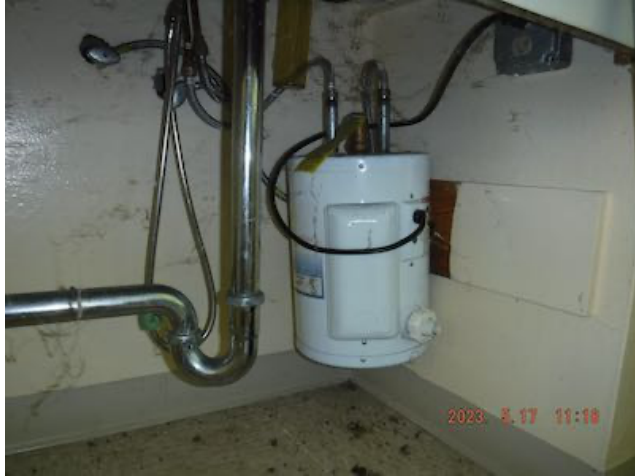
There is a 2½-gallon electric water heater below the sink in the large room at the left.

There was no hot water at the time of our inspection. The water heater was plugged into an operating electrical outlet and so is likely to have failed.

The water heater is 20 years old; it is in poor condition and we recommend it be replaced.

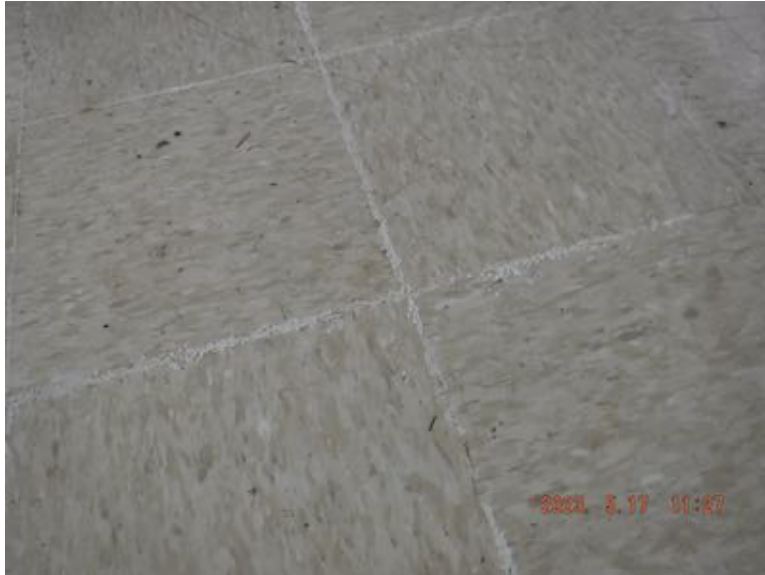
We observed efflorescence on the VCT (vinyl composition tile) flooring.

We recommend these floors be removed and replaced after the flooring has been inspected and suitably sealed using a properly rated sealant. Sealants should be selected, in part, based on what is to be installed over them. A good choice for replacement may be vinyl plank, if this is compatible with future anticipated use of the space. (e.g. This would not be a good choice if very hot items may be dropped or fall in the space as in glass blowing, ceramics, etc.)

We recommend all of the concrete floors be sealed and a drainage system be installed to aid in addressing the signs of moisture in the slab as well as surface flooding.
