Arbor Culture Consulting

Client: KPPCSD

Date: November 26, 2022

Introduction and Assignment

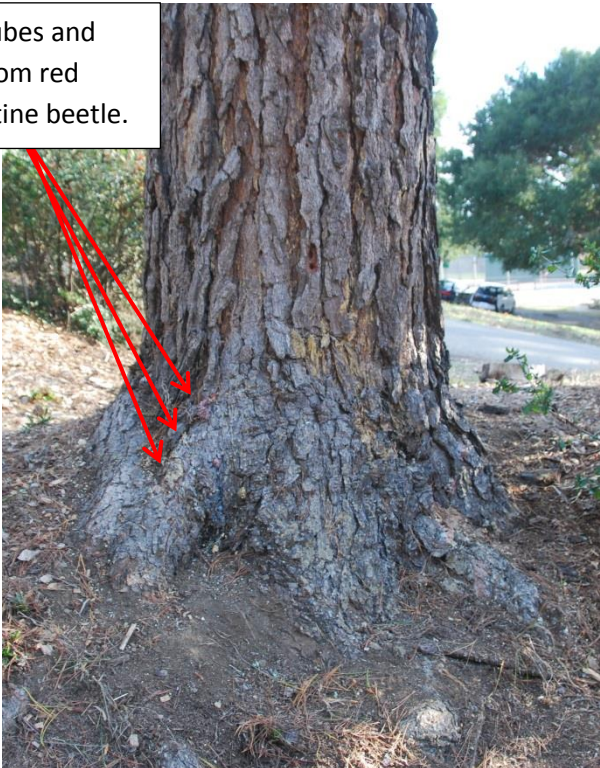
Photo A, tree #1

Tree #	Species	Condition 0=dead 5=excellent	Suitability for Preservation	Comments
1	Monterey pine (<i>Pinus radiata</i>)	1	Poor	Large deadwood and recent branch failures. There are dead sections at the base and evidence of beetle infestations (Photos A-B, page 9).
2	Monterey pine (<i>Pinus radiata</i>)	1	Poor	Co-dominant stems with significant decline throughout the canopy and evidence of beetle infestations.
3	Monterey pine (<i>Pinus radiata</i>)	1	Poor	Significant decline throughout the canopy and evidence of beetle infestations. Low LCR, all foliage is on the southwest side of the tree over the path.
4	Monterey pine (<i>Pinus radiata</i>)	1	Moderate	Small tree with co-dominant stems.
5	Monterey pine (<i>Pinus radiata</i>)	1	Poor	Significant decline throughout the canopy and evidence of beetle infestations. Low LCR, all foliage is on the southwest side of the tree over the path.
6	Monterey pine (<i>Pinus radiata</i>)	1	Poor	Significant decline throughout the canopy and evidence of beetle infestations. Low LCR.

Pitch tubes and frass from red turpentine beetle.

While Monterey pine can live well over a hundred years in their native coast habitats, their lifespan is reduced when grown as a landscape tree and in hotter, dryer areas. They will continue to decline and the likelihood of branch or tree failure will continue to increase. I recommend removal of trees #1-11 along Kensington Park Road, #12-21 along Highland Boulevard, and the two trees east of the community center (#25). Consider preserving the small grove of pines west of Windsor Avenue (#23) because the likelihood of them failing and hitting a target is low, and they provide valuable wildlife habitat.

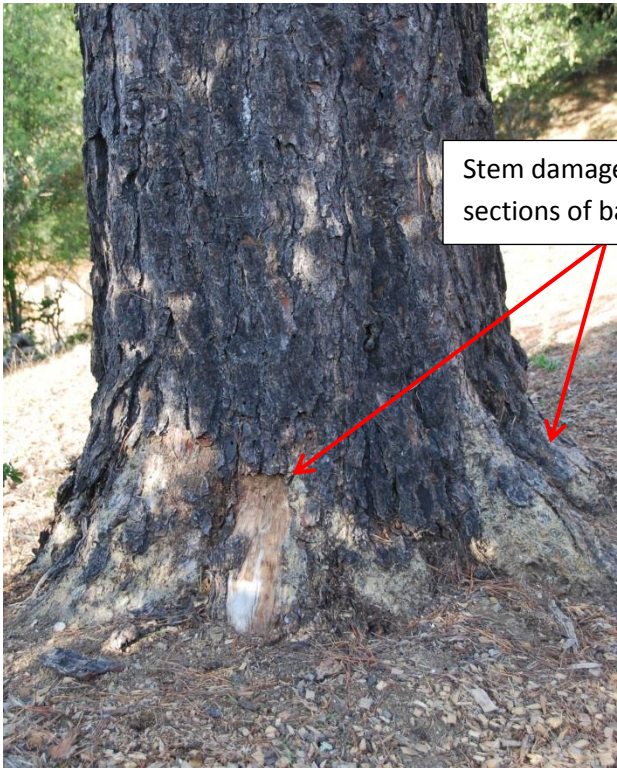
Photo B, tree #1

Stem damage and dead sections of basal flare.

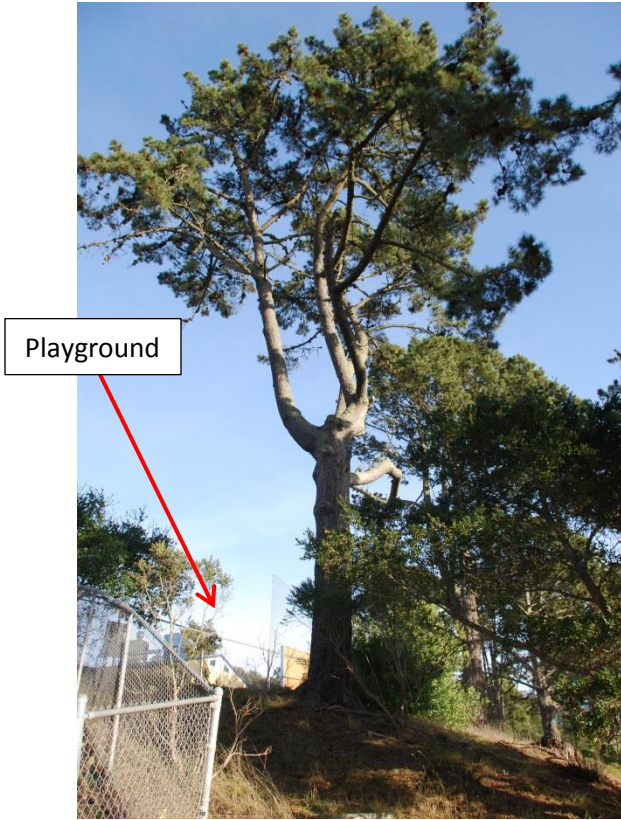
Photo D, tree #8

7	Monterey pine (<i>Pinus radiata</i>)	1	Poor	Significant decline throughout the canopy and evidence of beetle infestations and pine pitch canker. Low LCR, all foliage is on the southwest side of the tree over the path.
8	Monterey pine (<i>Pinus radiata</i>)	1	Poor	Topped, with large co-dominant stems and significant decline throughout the canopy. A lean toward the playground and evidence of beetle infestations. See Photo D, page 10.
9	Monterey pine (<i>Pinus radiata</i>)	1	Poor	Significant decline throughout the canopy and evidence of beetle infestations. Low LCR, all foliage on the southwest side of the tree over the path.
10	Monterey pine (<i>Pinus radiata</i>)	1	Poor	Topped, with large co-dominant stems and significant decline throughout the canopy. A lean toward the playground and evidence of beetle infestations. See Photo E, page 10.
11	Monterey pine (<i>Pinus radiata</i>)	1	Poor	Significant decline throughout the canopy and evidence of beetle infestations. Severe pine pitch canker infection and overhanging the path. See Photos G-H, pages 10-11.

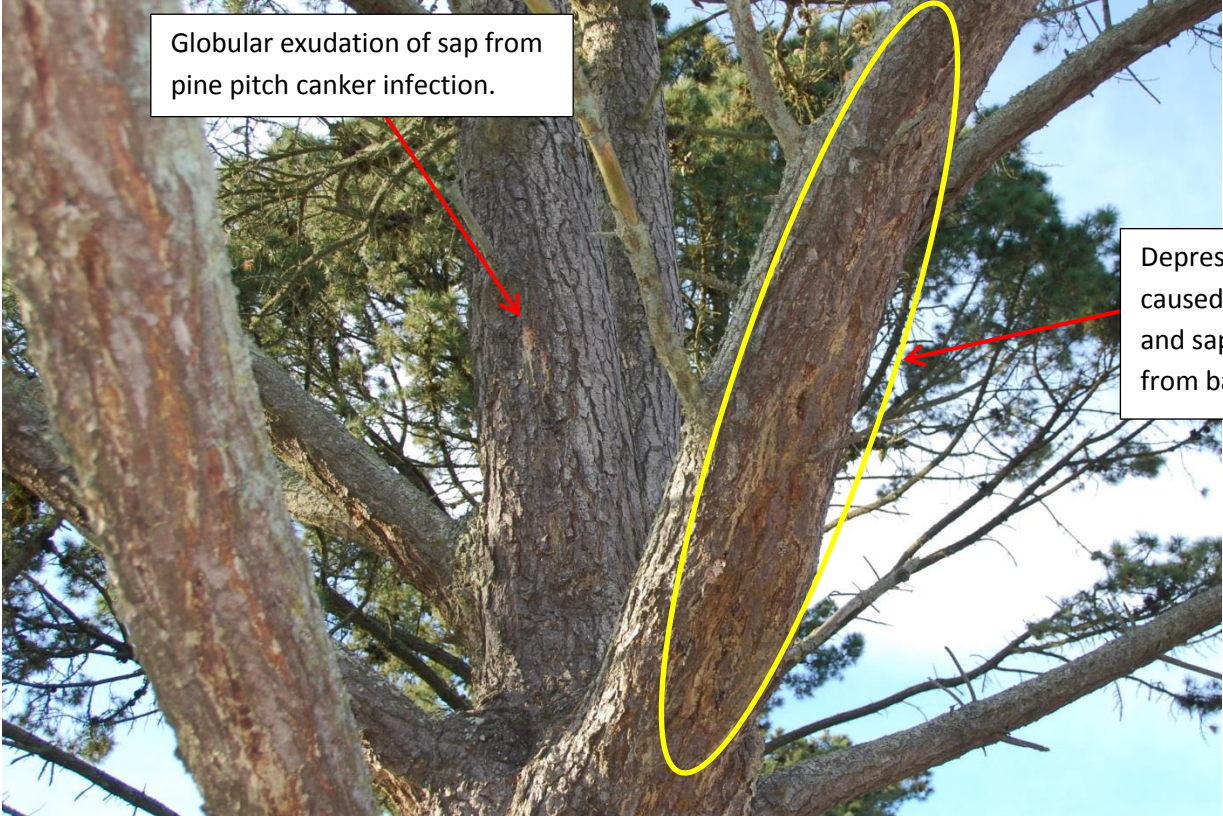
Photo H, tree #11

Depressed section caused by canker, and sap exudation from bark lesions.

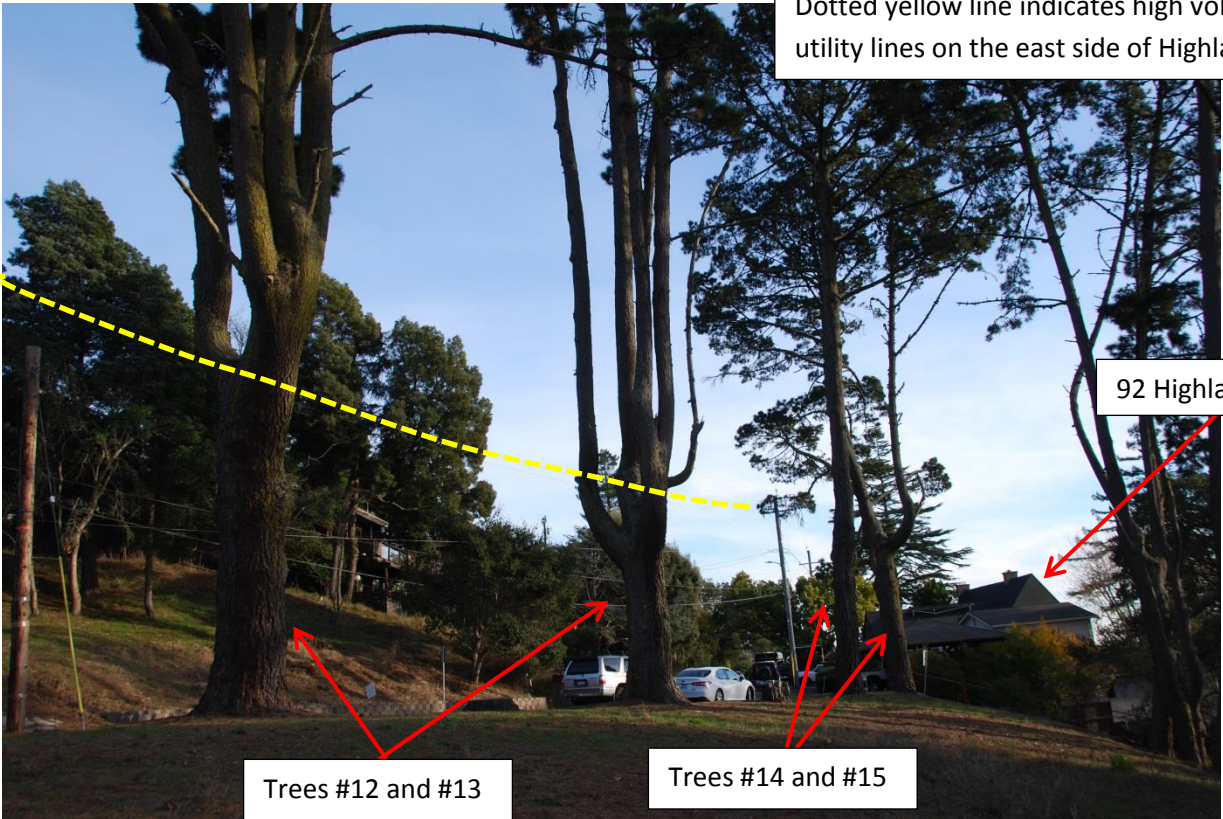
Photo I, trees #12 - #15

12	Monterey pine (<i>Pinus radiata</i>)	1	Poor	Topped, with co-dominant stems. Low LCR and large girdling root at the base. Evidence of beetle infestations and pine pitch canker infection. Within the fall distance of the high voltage utility lines on the east side of Highland Blvd.
13	Monterey pine (<i>Pinus radiata</i>)	1	Poor	Topped, with co-dominant stems. Low LCR and a depressed area of limited growth that may indicate a large girdling root below grade (Photo J, page 12). Evidence of beetle infestations and pine pitch canker infection. Within the fall distance of the high voltage utility lines on the east side of Highland Blvd.

Dotted yellow line indicates high voltage utility lines on the east side of Highland Blvd.

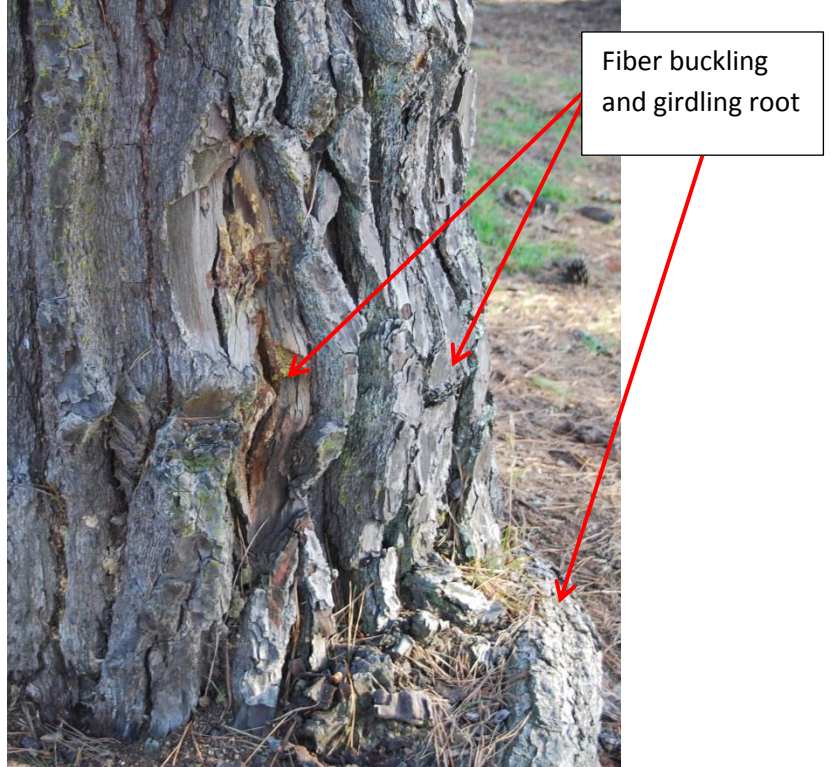
Photo K, tree #14

Tree #	Species	Condition 0=dead 5=excellent	Suitability for Preservation	Comments
14	Monterey pine (<i>Pinus radiata</i>)	1	Poor	Topped, with co-dominant stems and a low LCR. Large girdling root at the base, and fiber buckling on the lower stem which occurs when the linear load exceeds the wood strength (Photo K, page 12). Evidence of beetle infestations and pine pitch canker infection. Within the fall distance of the high voltage utility lines on the east side of Highland Blvd.
15	Monterey pine (<i>Pinus radiata</i>)	1	Poor	Topped, with co-dominant stems. Low LCR and large girdling root at the base. Evidence of beetle infestations and pine pitch canker infection. Leans to the south and is within the fall distance of 92 Highland Blvd. See Photo I, page 11.
16	Monterey pine (<i>Pinus radiata</i>)	1	Poor	Topped, with co-dominant stems. Low LCR, girdling root at the base, and a trunk wound on the lower stem. Evidence of beetle infestations and pine pitch canker infection.

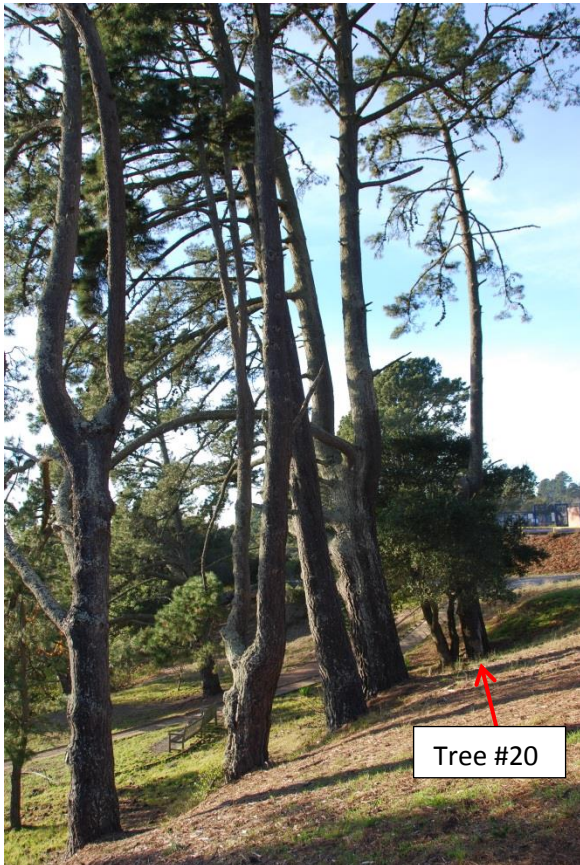
Photo L, trees #16 - #20

17	Monterey pine (<i>Pinus radiata</i>)	1	Poor	Topped, with co-dominant stems. Evidence of beetle infestations and pine pitch canker infection. Low LCR and canker lesions on the lower stem.
18	Monterey pine (<i>Pinus radiata</i>)	1	Poor	Topped, with co-dominant stems. Evidence of beetle infestations and pine pitch canker infection. Low LCR and a bow toward the west.
19	Monterey pine (<i>Pinus radiata</i>)	1	Poor	Topped, with co-dominant stems, a low LCR, and significant decline in the canopy. Fiber buckling on the lower stem which occurs when the linear load exceeds the wood strength.
20	Monterey pine (<i>Pinus radiata</i>)	1	Poor	Topped, and all but one of the co-dominant stems have been removed. Significant stem decay from grade up about 10 feet, and a large cavity at the base. This tree is an imminent risk and should be removed as soon as scheduling will allow. See Photo M, page 12.
21	Monterey pine (<i>Pinus radiata</i>)	1	Poor	Significant decline throughout the canopy and a large girdling root at the base. Evidence of beetle infestations and pine pitch canker. See Photos N and O, page 13.

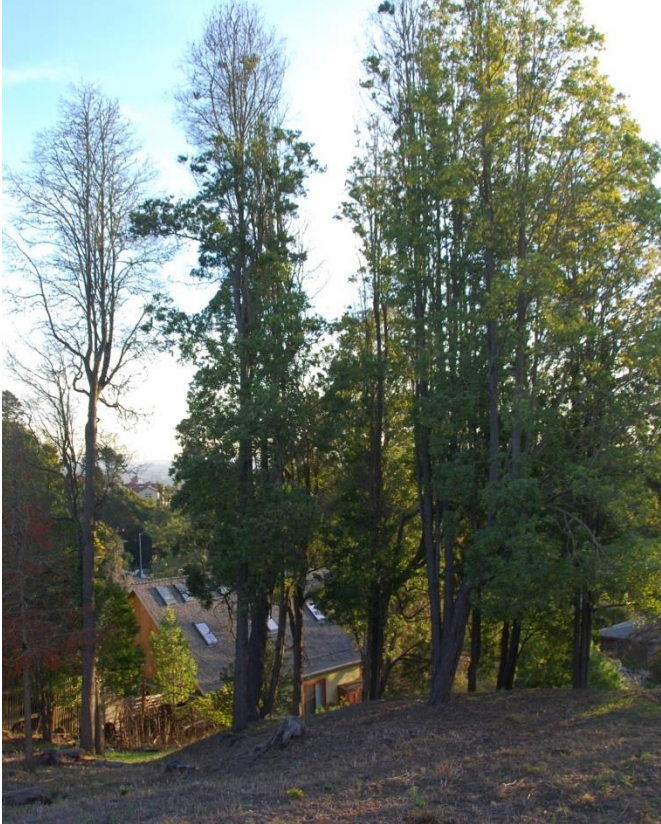
Photo P, #22 Acacias

The small grove of acacias west of Windsor Avenue is in decline. There is one dead tree and several others that have dead tops and will continue to decline (Photo P, page 13). There are also two other trees that appeared to be dead from my vantage point and may be coast redwood (*Sequoia sempervirens*).

22	Blackwood acacias (<i>Acacia melanoxylon</i>) west of Windsor Ave.	1	Moderate	The small grove of acacias west of Windsor Avenue is in decline. There is one dead tree and several others that have dead tops and will continue to decline. There are also two other dead/dying trees here that may be coast redwood (<i>Sequoia sempervirens</i>). See Photo P, page 13 and Figure 2: Site Sketch B, page 8.
23	Monterey pines (<i>Pinus radiata</i>) west of Windsor Ave.	1	Moderate	There is one dead tree in this small grove of pines. There is decline throughout the canopies and evidence of beetle infestations and pine pitch canker. One of the trees leans to the south over an informal path that leads up from Arlington Ave. See Photos Q, R, pages 13-14 and Figure 2: Site Sketch B, page 8.

There are dead and dying trees in this grove and they will all continue to decline. They are in an undeveloped area with no discernable pedestrian paths in the immediate area. Consider preservation of these trees because the likelihood of them failing and hitting a target is low, and they provide valuable wildlife habitat.

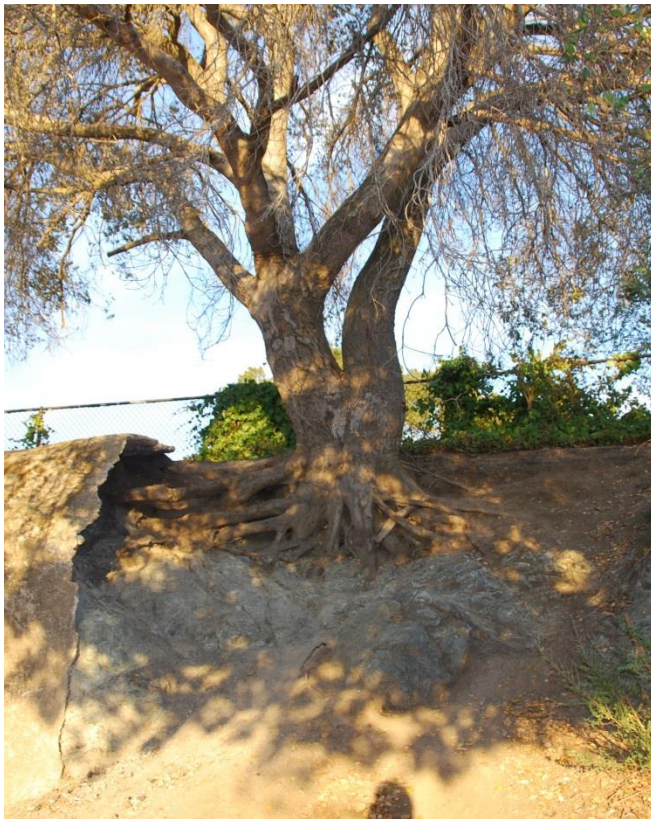
Photo S, tree #24

This tree is growing on a steep bank southwest of the basketball courts. There are several exposed roots and they are growing over what appears to be a natural rock formation (Photo S, page 14). The canopy is sparse with some dead branches, similar to some other trees in the vicinity. There is no indication the tree is likely to fail.

Tree #	Species	Condition 0=dead 5=excellent	Suitability for Preservation	Comments
24	Coast live oak (<i>Quercus agrifolia</i>)	3	Good	The structure of this tree is good, but the health is struggling (Photo S, page 14). Many local coast live oaks are struggling from years of drought, and there are similar oaks on this property. See Discussion and Recommendations for care recommendations.
25	2-Monterey pine (<i>Pinus radiata</i>)	0	Poor	There are two dead trees near the playground that should be removed as soon as scheduling will allow. See Photo T, page 14.

The oak should be preserved. Future pruning should consist of removing dead branches one inch in diameter or greater. Care should be taken to limit the removal of any live foliage to only what is necessary to meet the minimum clearance needs.
