Date: May 11, 2023
To: Board of Directors
From: David Aranda, Interim General Manager
Subject: Contractual Agreement between KPPCSD and Kensington Community Council (KCC)

**AGREEMENT BETWEEN THE KENSINGTON POLICE PROTECTION
AND COMMUNITY SERVICES DISTRICT AND THE KENSINGTON
COMMUNITY COUNCIL REGARDING RECREATIONAL AND
EDUCATIONAL PROGRAM SERVICES**

- 3.1. The District has obtained a report from Cantor Inspections dated April 26, 2023, that details conditions in the Recreation Building that require significant maintenance and repair (“Cantor Report”). A copy of the Cantor Report is set forth in Exhibit in E.

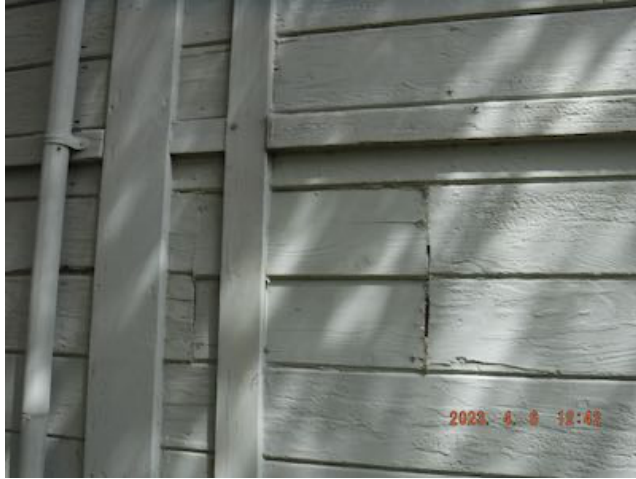
This building has horizontal wood siding. The siding shows moderate wear. Moderate damage was seen in a few places, but none was deemed significant. This was mostly in the form of improperly staggered cuts that are likely to have been access panels or poor repairs. See an example below.

We recommend that these areas be properly nailed and filled prior to painting.

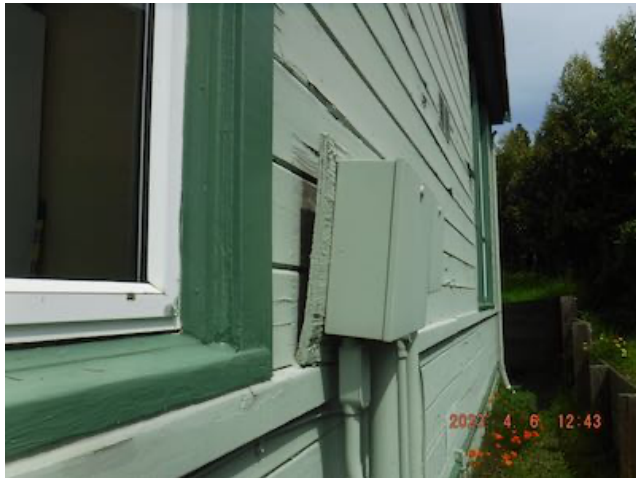
Low voltage electrical equipment is mounted on the left-hand side of the building using a plywood panel which has become loose from the siding.

This has only a very minor effect on the building itself and should be referred to the installer or maintenance parties related to the low voltage equipment.

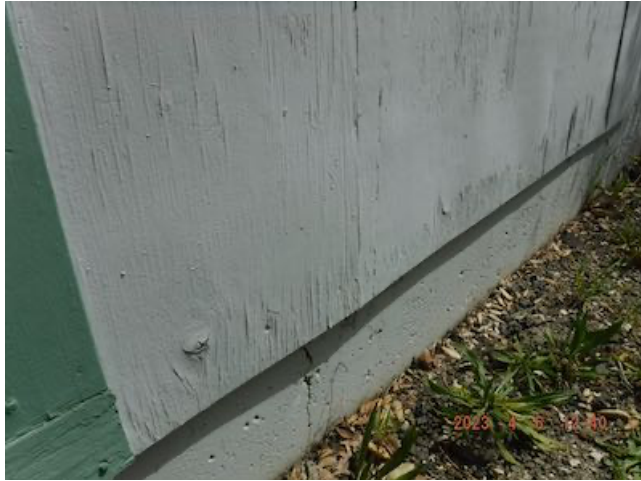
There is plywood siding at the building skirt, mostly at the rear. This siding shows moderate wear with some localized damage. See this below.

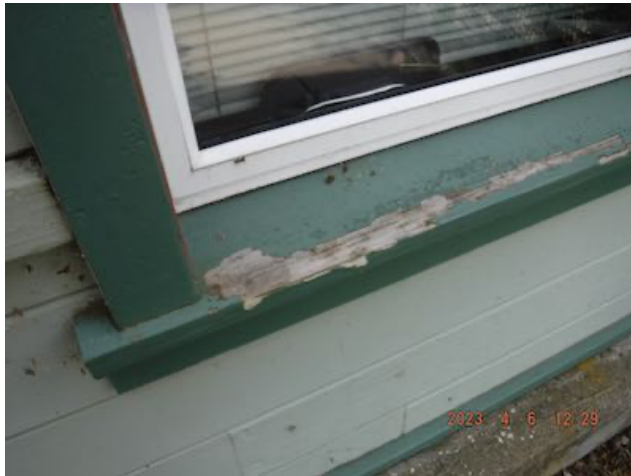
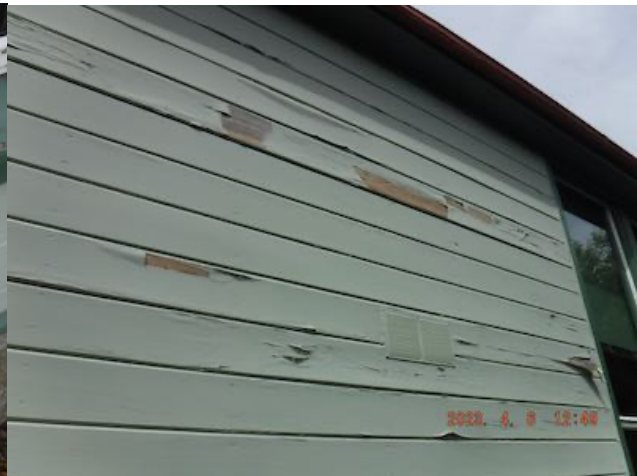
The paint is peeling on the siding and trim in several places. We recommend the peeling paint be scraped, sanded, caulked, primed, and painted as needed by a qualified painting contractor.

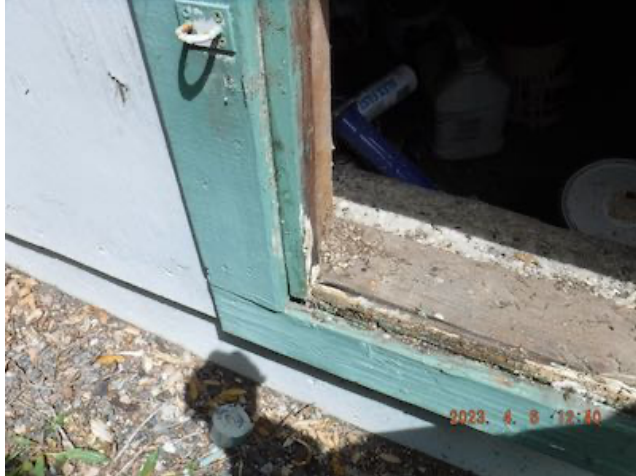
The trim is damaged in a few places. See some of this, below, around one of the two crawlspace openings at the rear.

We recommend the damaged trim be repaired or replaced as needed. None of this was highly critical.

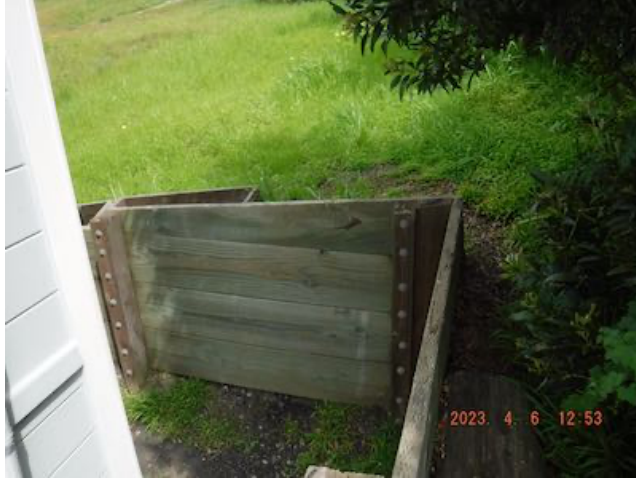
There are wooden retaining walls at the front/right. These walls are not provided with sufficient barriers or guardrails to prevent a fall. See below.

We recommend adequate safety barriers be installed.

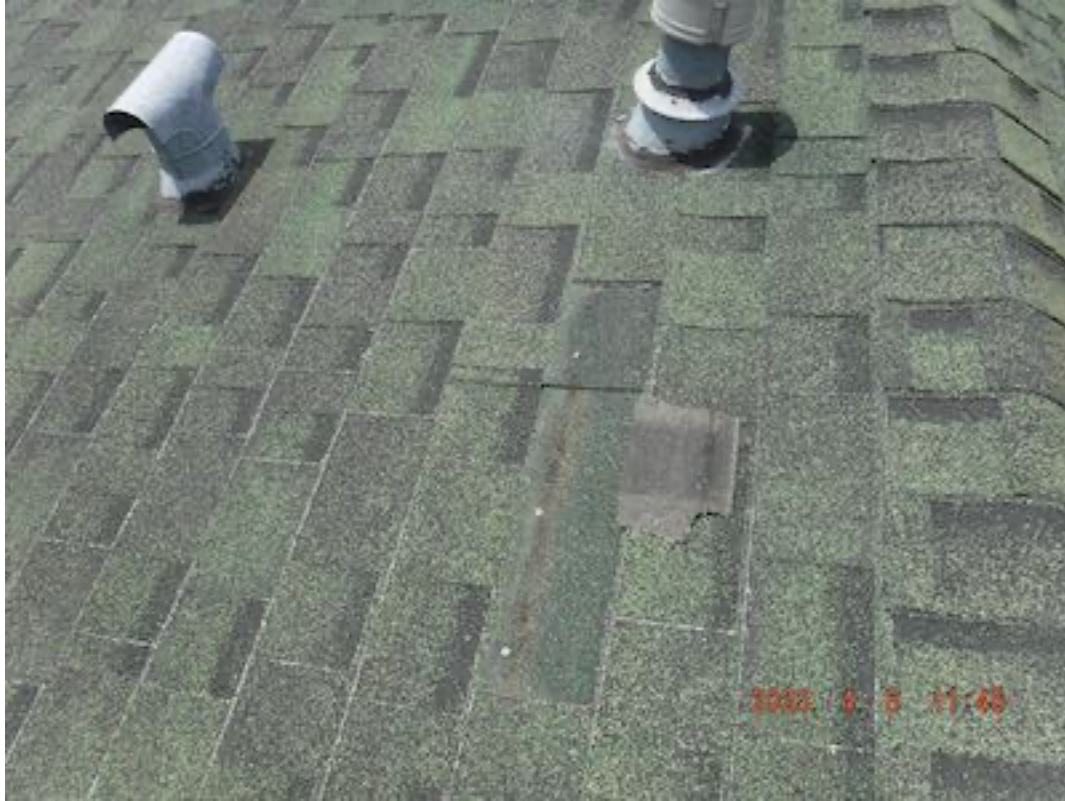
The building has a laminated composition shingle roof, which is in very worn condition and damaged in several places. See the damage below.

There are several exposed fasteners. With time exposed fasteners will rust and loosen and may cause leakage.

The roofing shows evidence of numerous repairs and has been extensively patched in several places, likely indicating previous roof leakage.

We recommend a new roof surface be installed.

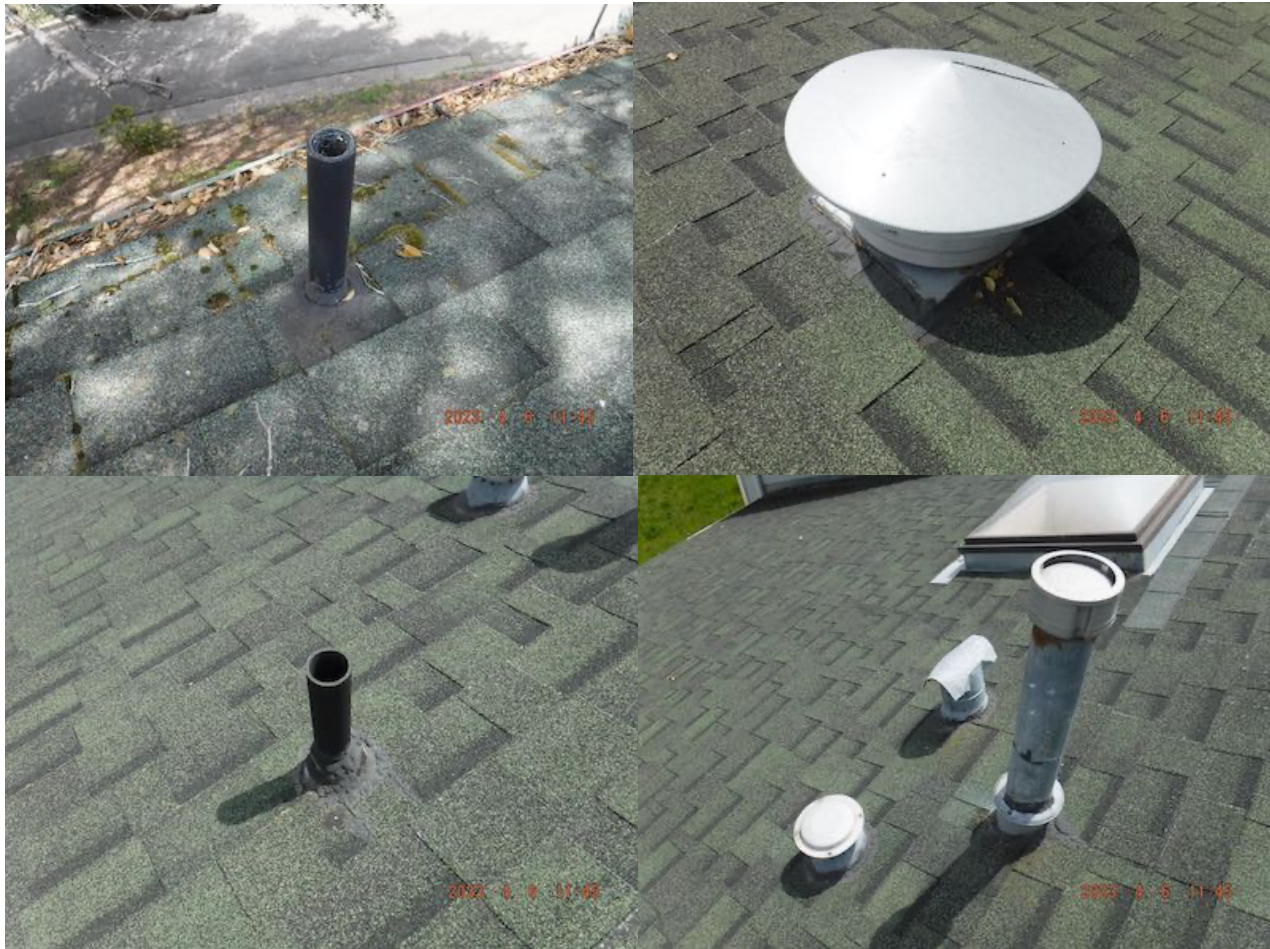
Several of the piping penetrations lack proper flashings and rely upon mastic predominately. See below.

We recommend that all of the flashings be replaced with the new roof.

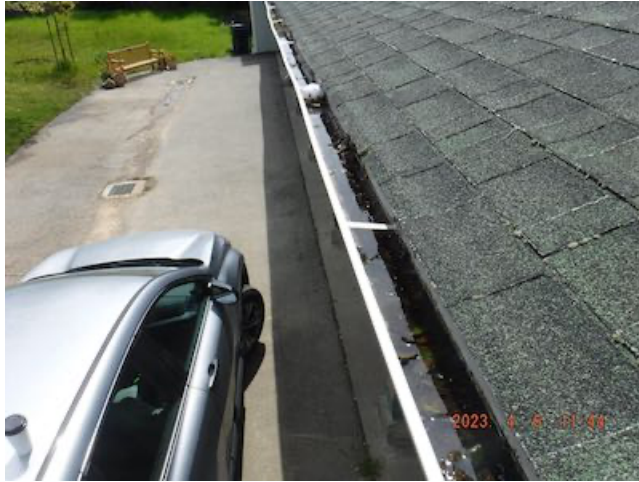
Debris has accumulated densely in several places in the gutters. There are signs of previous standing water in several places.

We recommend the gutters be cleaned and re-examined, and modified as needed to drain freely. Rain gutters should be cleared periodically as part of routine maintenance.

We recommend strainers be installed in the gutters to minimize clogging by debris.

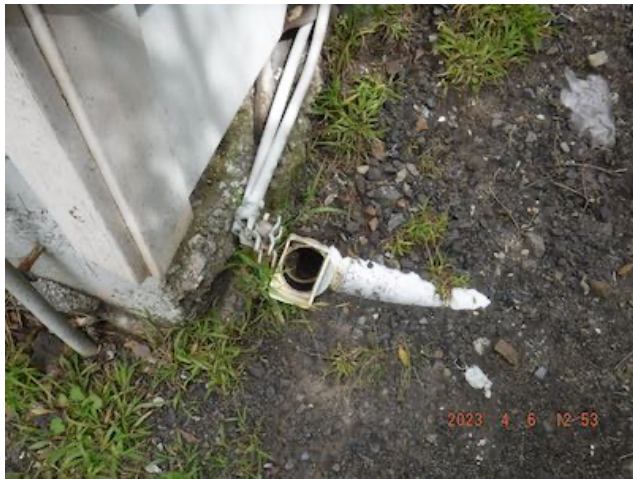
Several downspouts are disconnected at the top or bottom and we recommend repair.

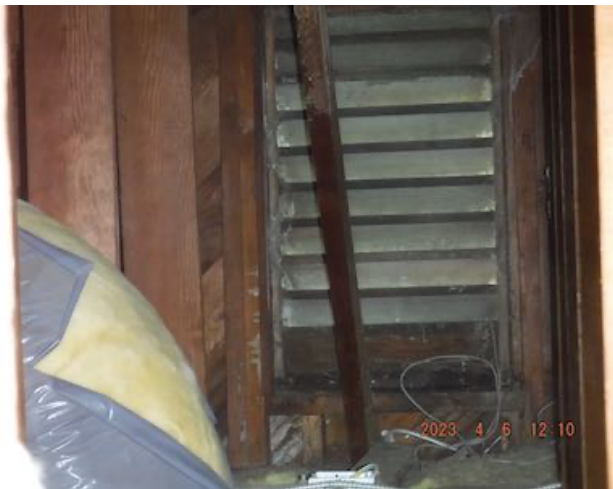
Several attic vents are not screened.

We recommend the vents be screened to prevent animal entry.

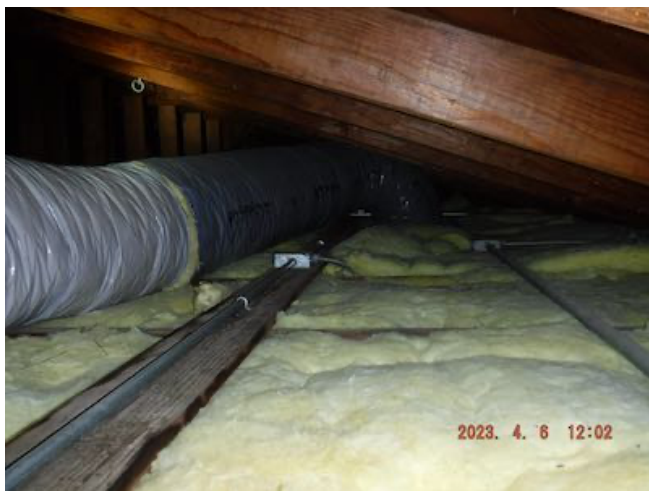
The attic is insulated with fiberglass batts that are approximately 4 to 7 inches thick.

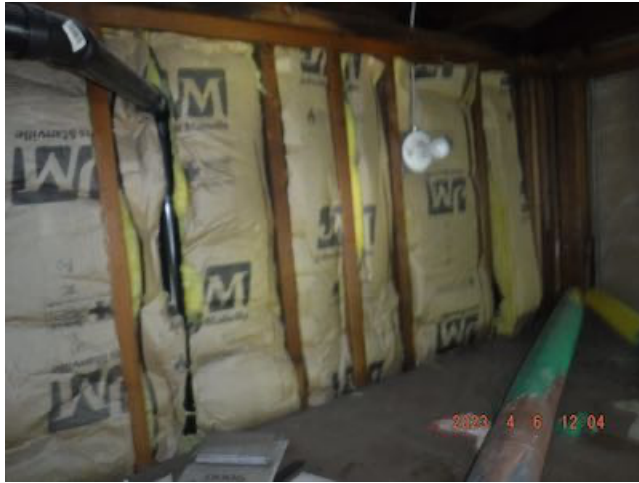
The insulation in the attic vestibules near the furnace has been installed reversed with the paper backing facing the open space. See an example below.

Inverted vapor barriers can constitute a fire hazard. A warning to this effect is typically found on the insulation vapor barrier. The vapor barrier should be placed against a solid backing, toward the interior of the dwelling and should never be visible from the crawlspace or the attic. In humid environments, this inversion can also cause the accrual of condensation and can damage framing. We recommend vapor barriers be properly placed.

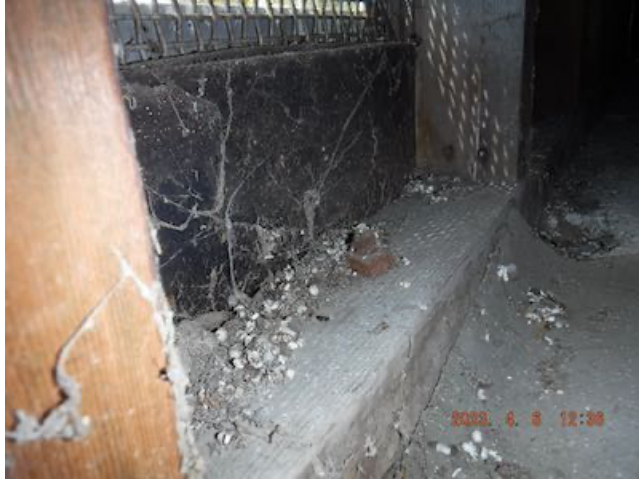
The foundation is equipped with a few, small, rusty anchor bolts. See one below.

As a rule, foundation bolts installed in most of the 20th century fall short of the strength mandated by engineers when seismic retrofitting is done. Currently engineers will typically call for a larger number of bolts (more per linear foot of foundation), larger bolts, improved washers and well tightened bolting. It is also clear that rusting of non-galvanized bolting, which is the kind used in nearly all foundations, leads to weakening over just a few decades and they can lose much of their strength after many decades. Older bolts should be replaced by new, improved bolting in all houses located near major fault lines.

We recommend additional anchor bolts be installed as needed by a qualified contractor.

We recommend a qualified engineer be retained to design or specify seismic upgrades appropriate for this building.

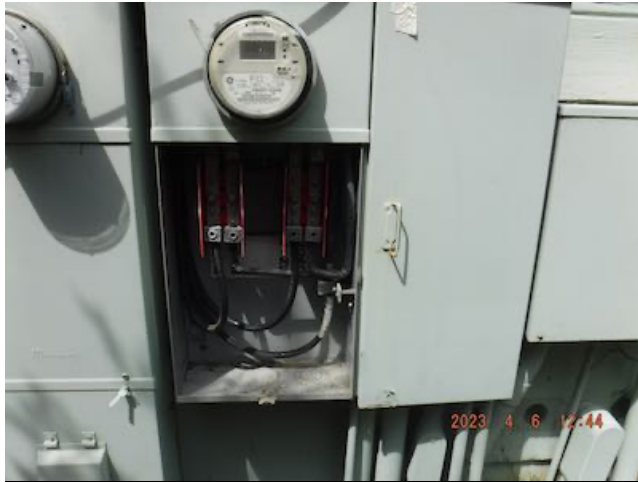
One of the panels in this main service assembly is not designed to be open by users and contains exposed hot terminals that could kill if opened by nonprofessionals. We urge that this panel be repaired for security immediately. See this below.

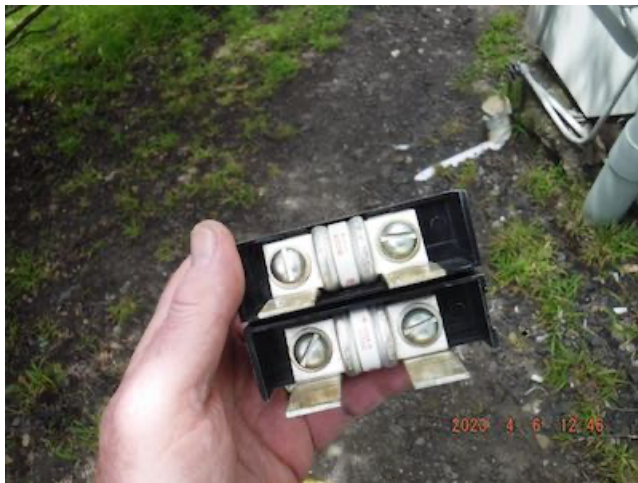
There is both a breaker main panel and a fuse main panel at the left exterior. Fuses in the latter panel are used for high voltage protection, as opposed the more outdated fuses of panels from the 1940 and earlier. The use of fuses (T type 200 amp shown below) in this case is not a concern for us, though more modern equipment will generally use solely breakers and add convenience.

The assembly of panels is damaged in several places, and we recommend repair or replacement by a qualified electrician. The panels also appear to be worn past a reasonable point of repair and maintenance and we suggest replacement of the entire assembly.

The left panel is in very worn condition, damaged in several places, and will soon need replacement. We recommend the left main panel be repaired or replaced by a qualified electrician.

The right fuse panel is very rusty and we recommend it be replaced.

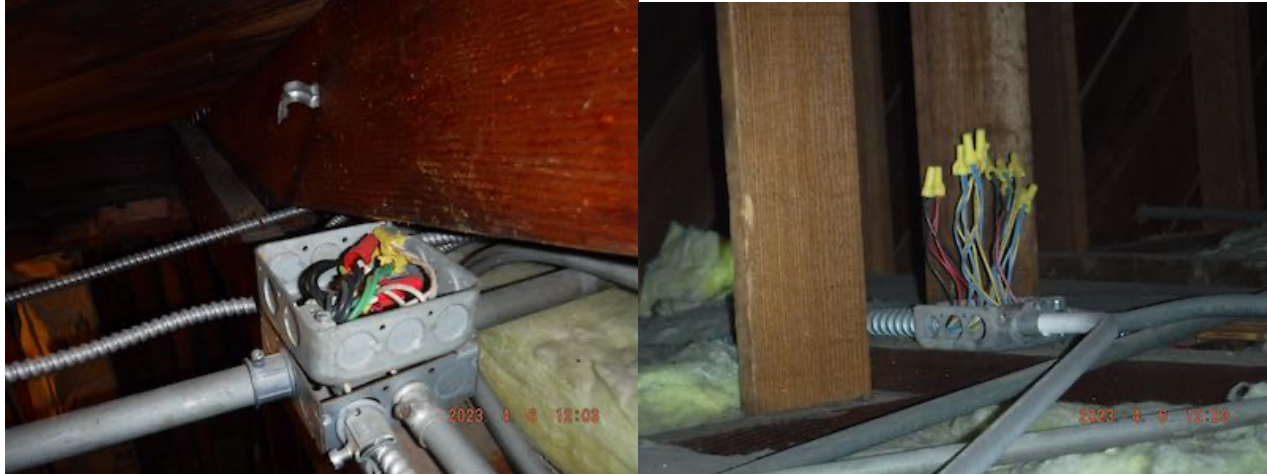
Several attic area electrical boxes are uncovered. We recommend box covers be installed as needed in the subfloor area. See two below.

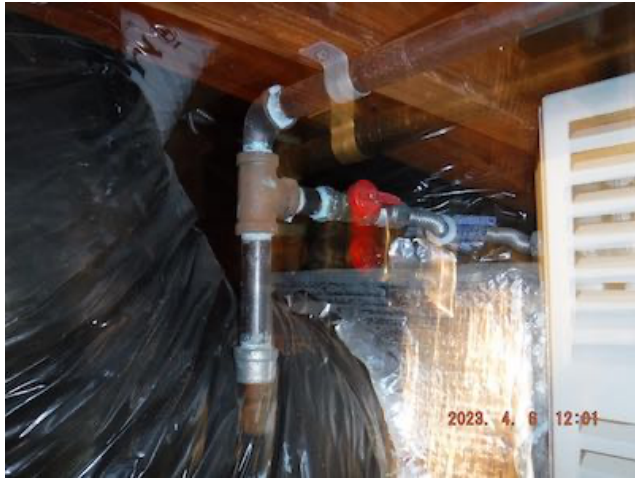
The sediment trap is installed before the gas valve instead of after and we recommend it be properly installed. This helps to deliver dry gas and prevent gas appliance failure. See this below.

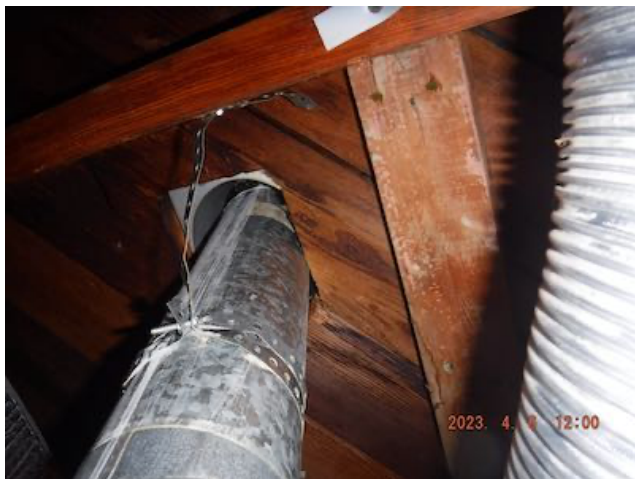
The double-wall vent piping is too close to roof sheathing and insulation, which is a potential fire hazard. See below.

We recommend adequate vent pipe clearance be provided. Double-wall vent pipes need at least 1-inch clearance from combustibles.

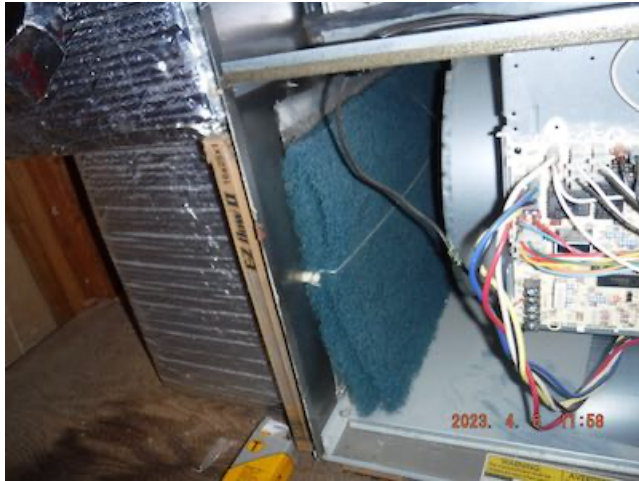
There is also a separate filter to the left of the unit and this lacks a proper filter cover as required. We recommend that a proper filter cover be installed by a qualified heating contractor.

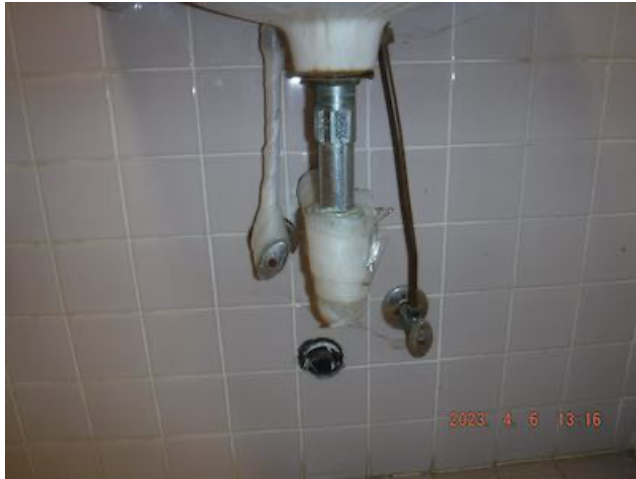
The ADA sink protection is incomplete in this bath. This can allow for scalding of some individuals and we recommend review of this and all related ADA issues with a qualified expert/contractor. See below.

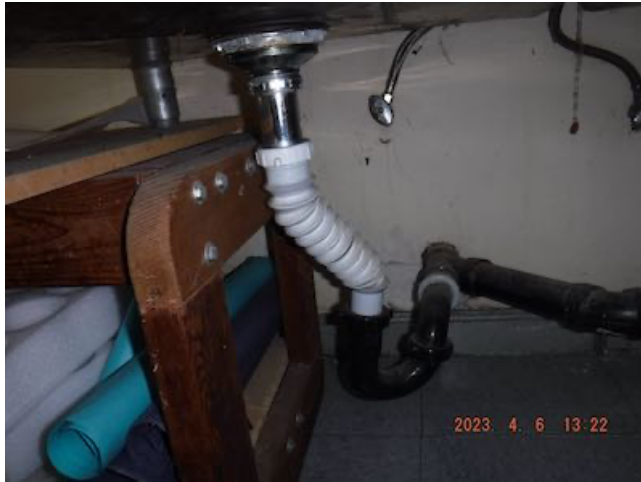
Art Sink

There is a stainless steel art sink in the main room at the rear. Flexible plastic waste piping is used at the sink drain and we recommend it be replaced with proper, smooth wall drain piping.

Corrugated drainage connectors are often installed by non-professionals to form drain traps or other drainage connections. These materials do not have smooth interior waterways and collect sludge. They are not approved and should be replaced with conventional drainage fittings and materials.
