# GEOTECHNICAL STUDIES AND FAULT HAZARD INVESTIGATION POLICE DEPARTMENT BUILDING SITE ARLINGTON AVENUE, APN: 572-040-011 KENSINGTON, CALIFORNIA

September 23, 2024  
3194-1A, L-33486

RE: Geotechnical Studies and Fault Hazard Investigation  
Police Department Building Site  
Arlington Avenue, APN: 572-040-011  
Kensington, California

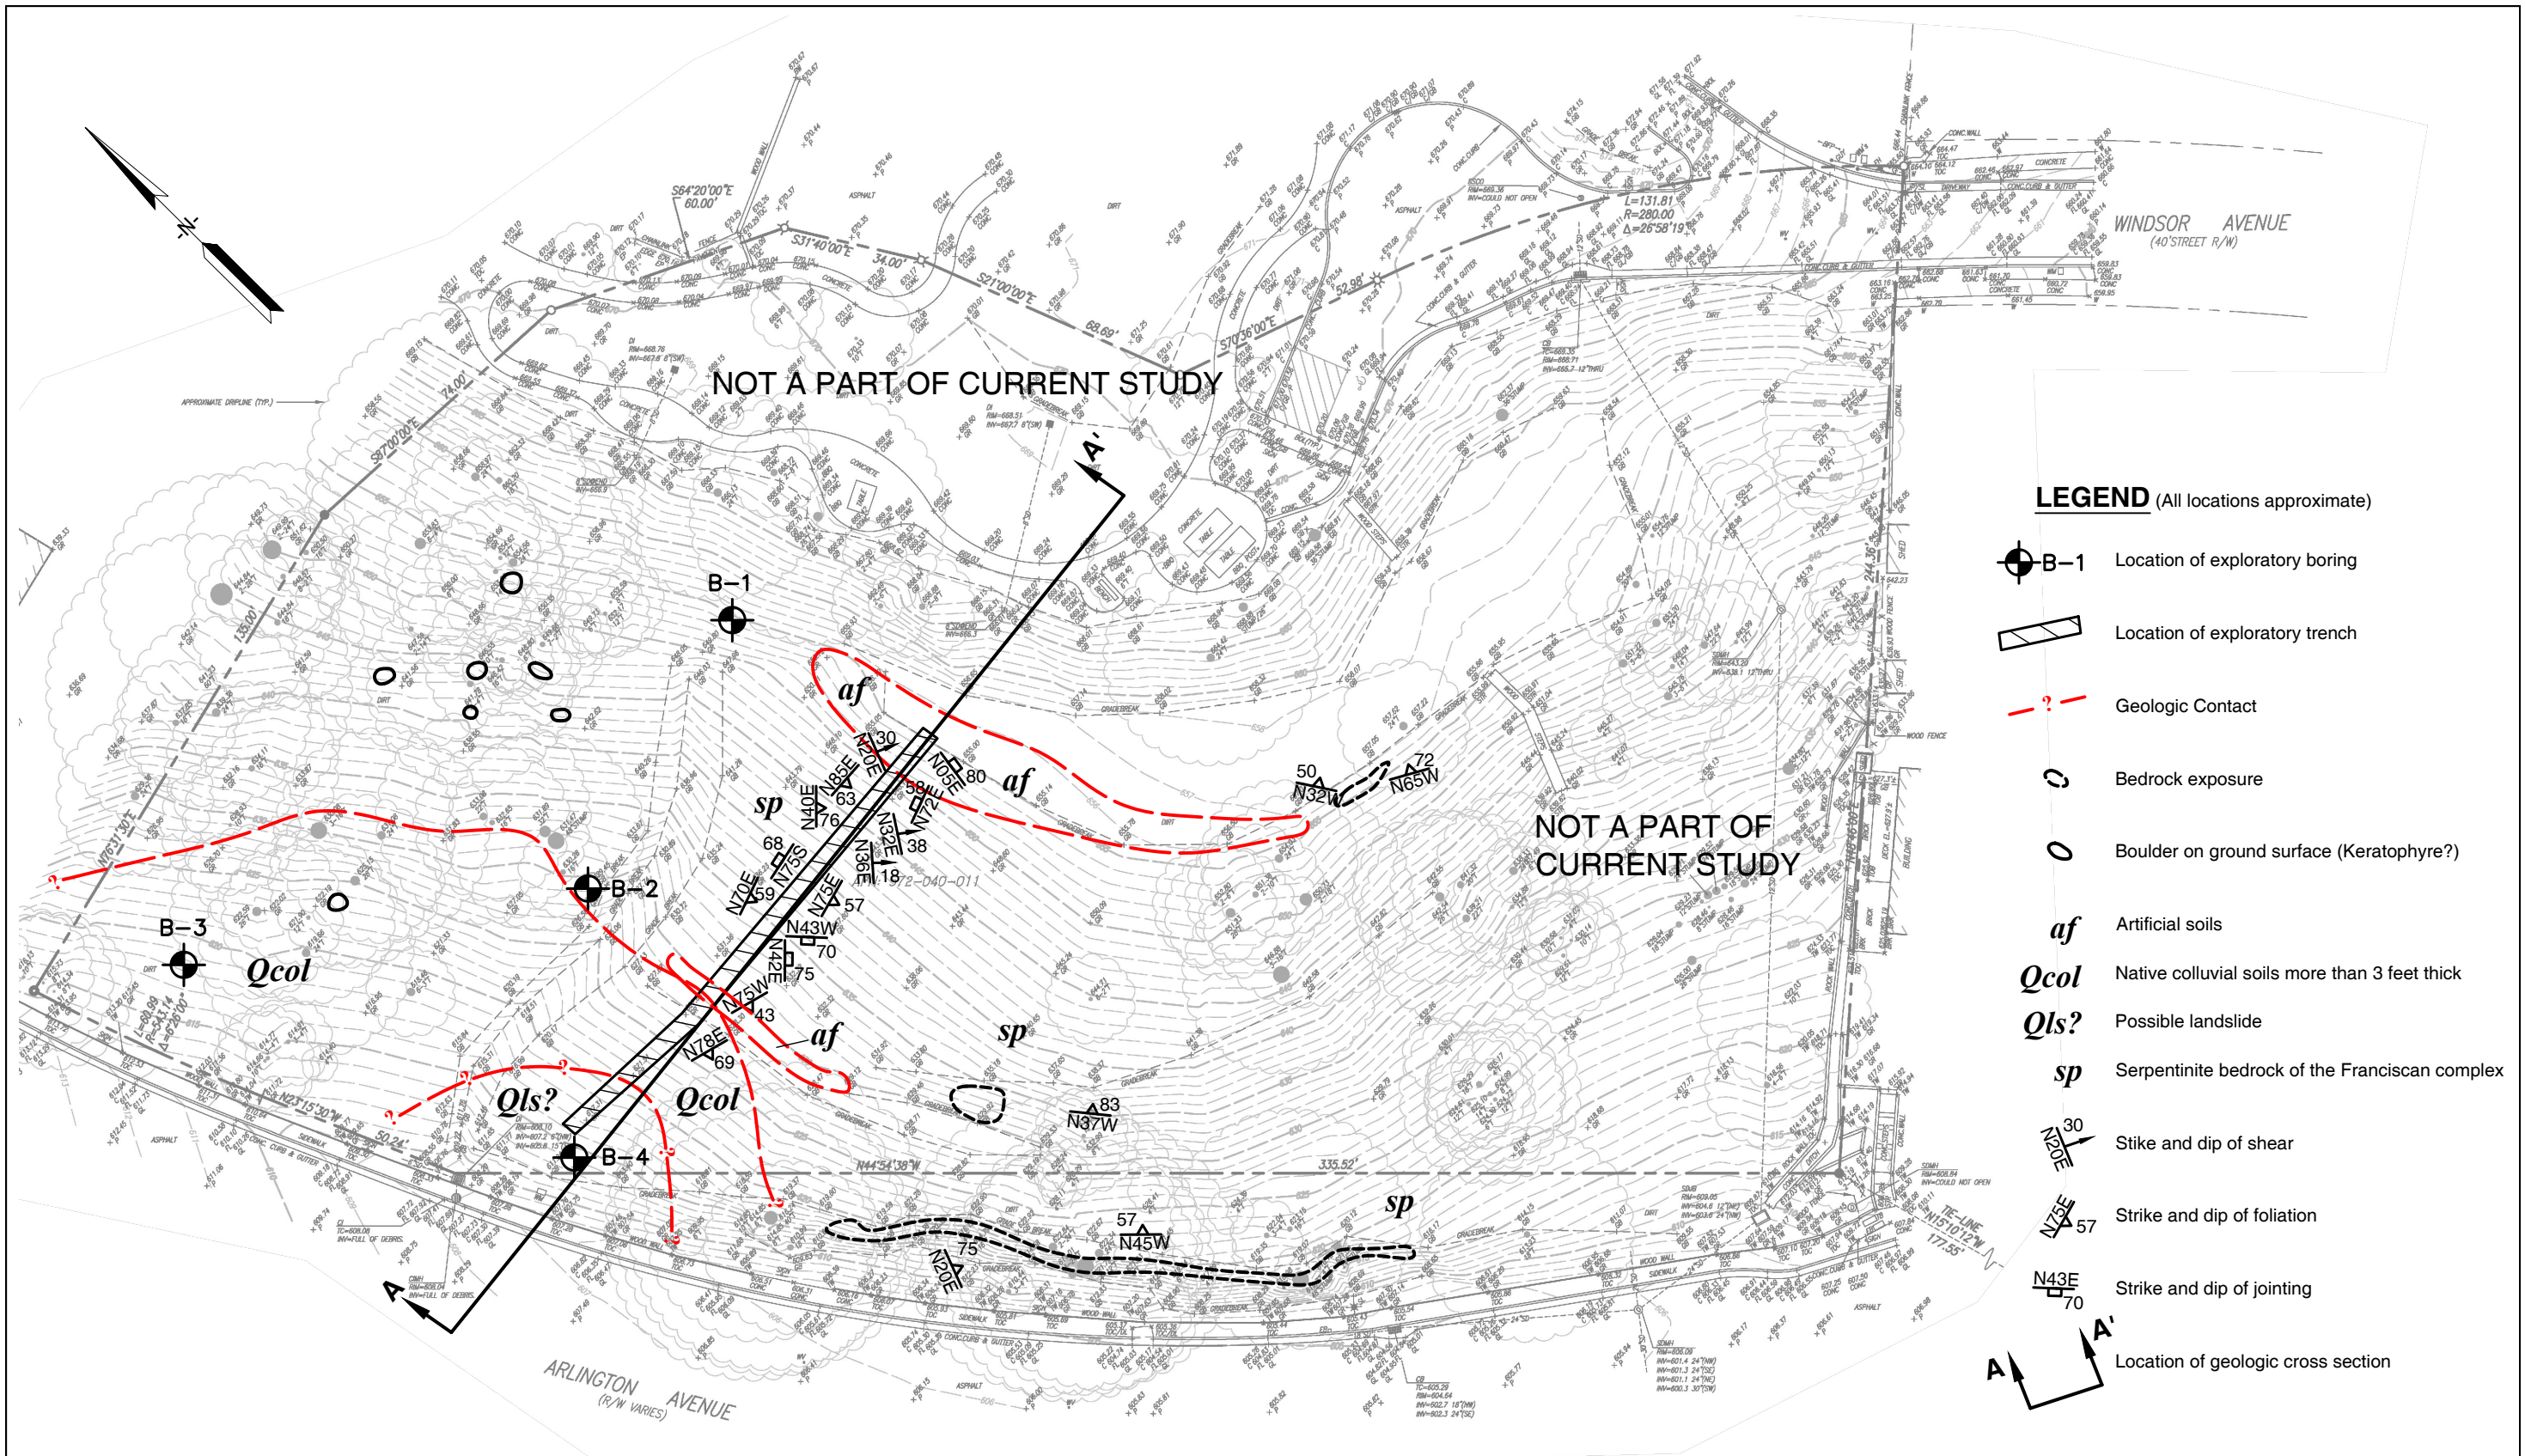
| SITE PLAN | | |
|---|---|---|
| PROJECT NO.<br><b>3194-1A</b> | DATE<br><b>September 2024</b> | FIGURE<br><b>2</b> |

We visited the project site several times prior to the boring and trench exploration phase of the project to observe the site conditions, identify any obvious slope instability and active fault features, and geologically map bedrock exposures. The proposed site is below and to the west of the main portion of Kensington Park. The park generally consists of an extensive level area with tennis courts, play areas, picnic tables, restroom facilities, and a paved cut-de-sac access off of Windsor Avenue. It appears that the level park area was created by excavating into the natural slope. We observed that portions of the upper southeast-facing slope below the picnic areas had also been graded in the past to form a level bench area that follows the contours of the natural slope. The lower shoulder of this bench is underlain by artificial fill as shown on Figure 2. The slope area of the site to the north within the trees is littered with boulders that appeared to have been pushed over the slope during of the park area (see Figure 2).

Below the park facilities and at the north end of the site, we observed scattered boulders of various sizes amongst the trees. The boulders were relatively hard and thought to be possibly keratophyre (see Figure 2). Even though some of these boulders were partially buried in the ground, it is unlikely that the boulders represent the underlying bedrock. Since some of the boulders were above the ground surface and located behind tree trunks suggests that the boulders were generated by the grading and development of the park and most likely were pushed over the side of the slope.

The bedrock exposed within the trench was consistently serpentinite with variations in color, weathering, strength characteristics, and degree of fracturing. The top of the bedrock surface dove below the bottom of the trench excavation at Station 108. The prominent foliations measured within the bedrock was striking northwest and northeast and dipping to the southwest and southeast from 43 to 76 degrees. The prominent joint planes were measured as striking northwest and northeast and dipping at moderate to steep inclination in all directions (see Figure 2).

Two areas of fill materials were encountered at the site (see Figure 2). We have not received any documentation to indicate these materials were placed under engineering observation. The fill materials appeared to be soft, and no ground preparation was noted below the fill materials in our trench logging. Therefore, we believe these materials could be subject to future settlement or lateral movements below the proposed building or on other portions of the site, and we recommend the fill materials be entirely removed by excavation. It is possible the excavated materials may be reused in new engineered fill at the site.

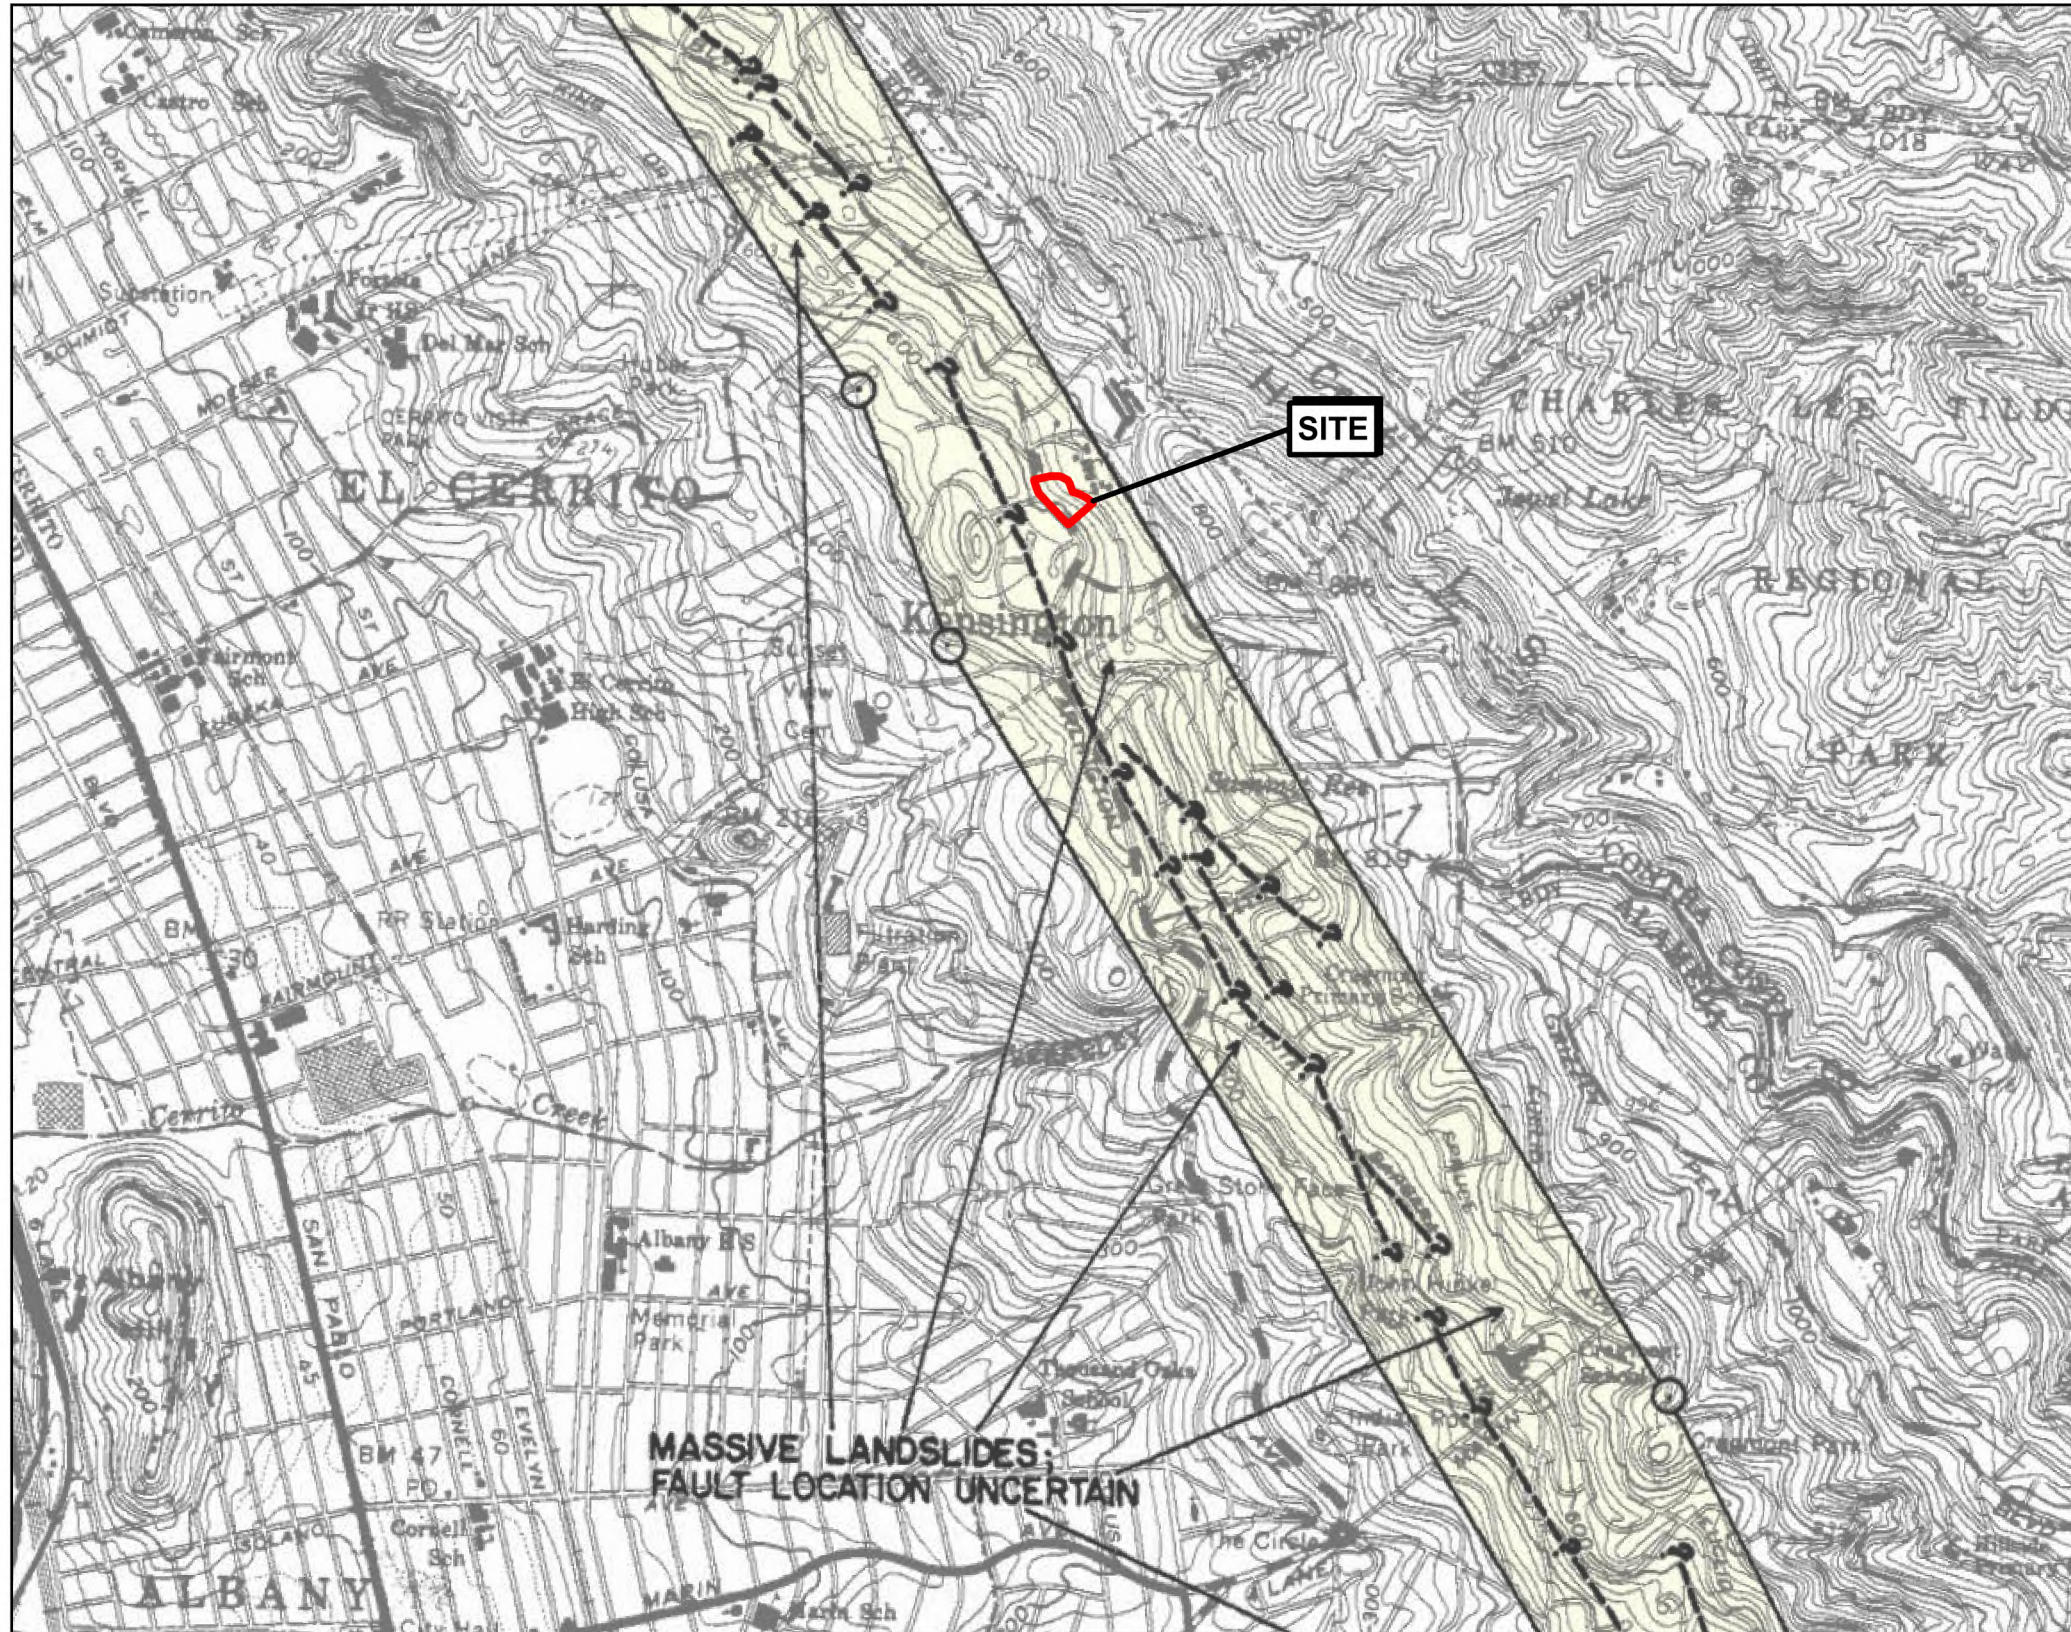
| PROJECT NO.<br><b>3194-1A</b> | DATE<br><b>September 2024</b> | <b>FIGURE 3</b> |

The site is located within the Alquist-Priolo Earthquake Fault Zone (APEFZ) established by the State of California for the seismically active Hayward fault as shown on Figure 3 (California Geological Survey, 1982). Therefore, a fault investigation conforming to the standards of the California Geologic Survey had to be performed to clear the proposed building area of the site. In addition, some concerns regarding slope stability at the site have been raised. The site is also included within a State of California Seismic Hazard Zone for Earthquake-Induced Landslides as shown on Figure 4 (California Geological Survey, 2024a). Our assessment of the site presented here follows general guidelines established by California Geologic Survey Special Publication 117A (2008). Therefore, fault evaluation and landslide assessment have been performed by Certified Engineering Geologist, Patrick Drumm, for EFGS.

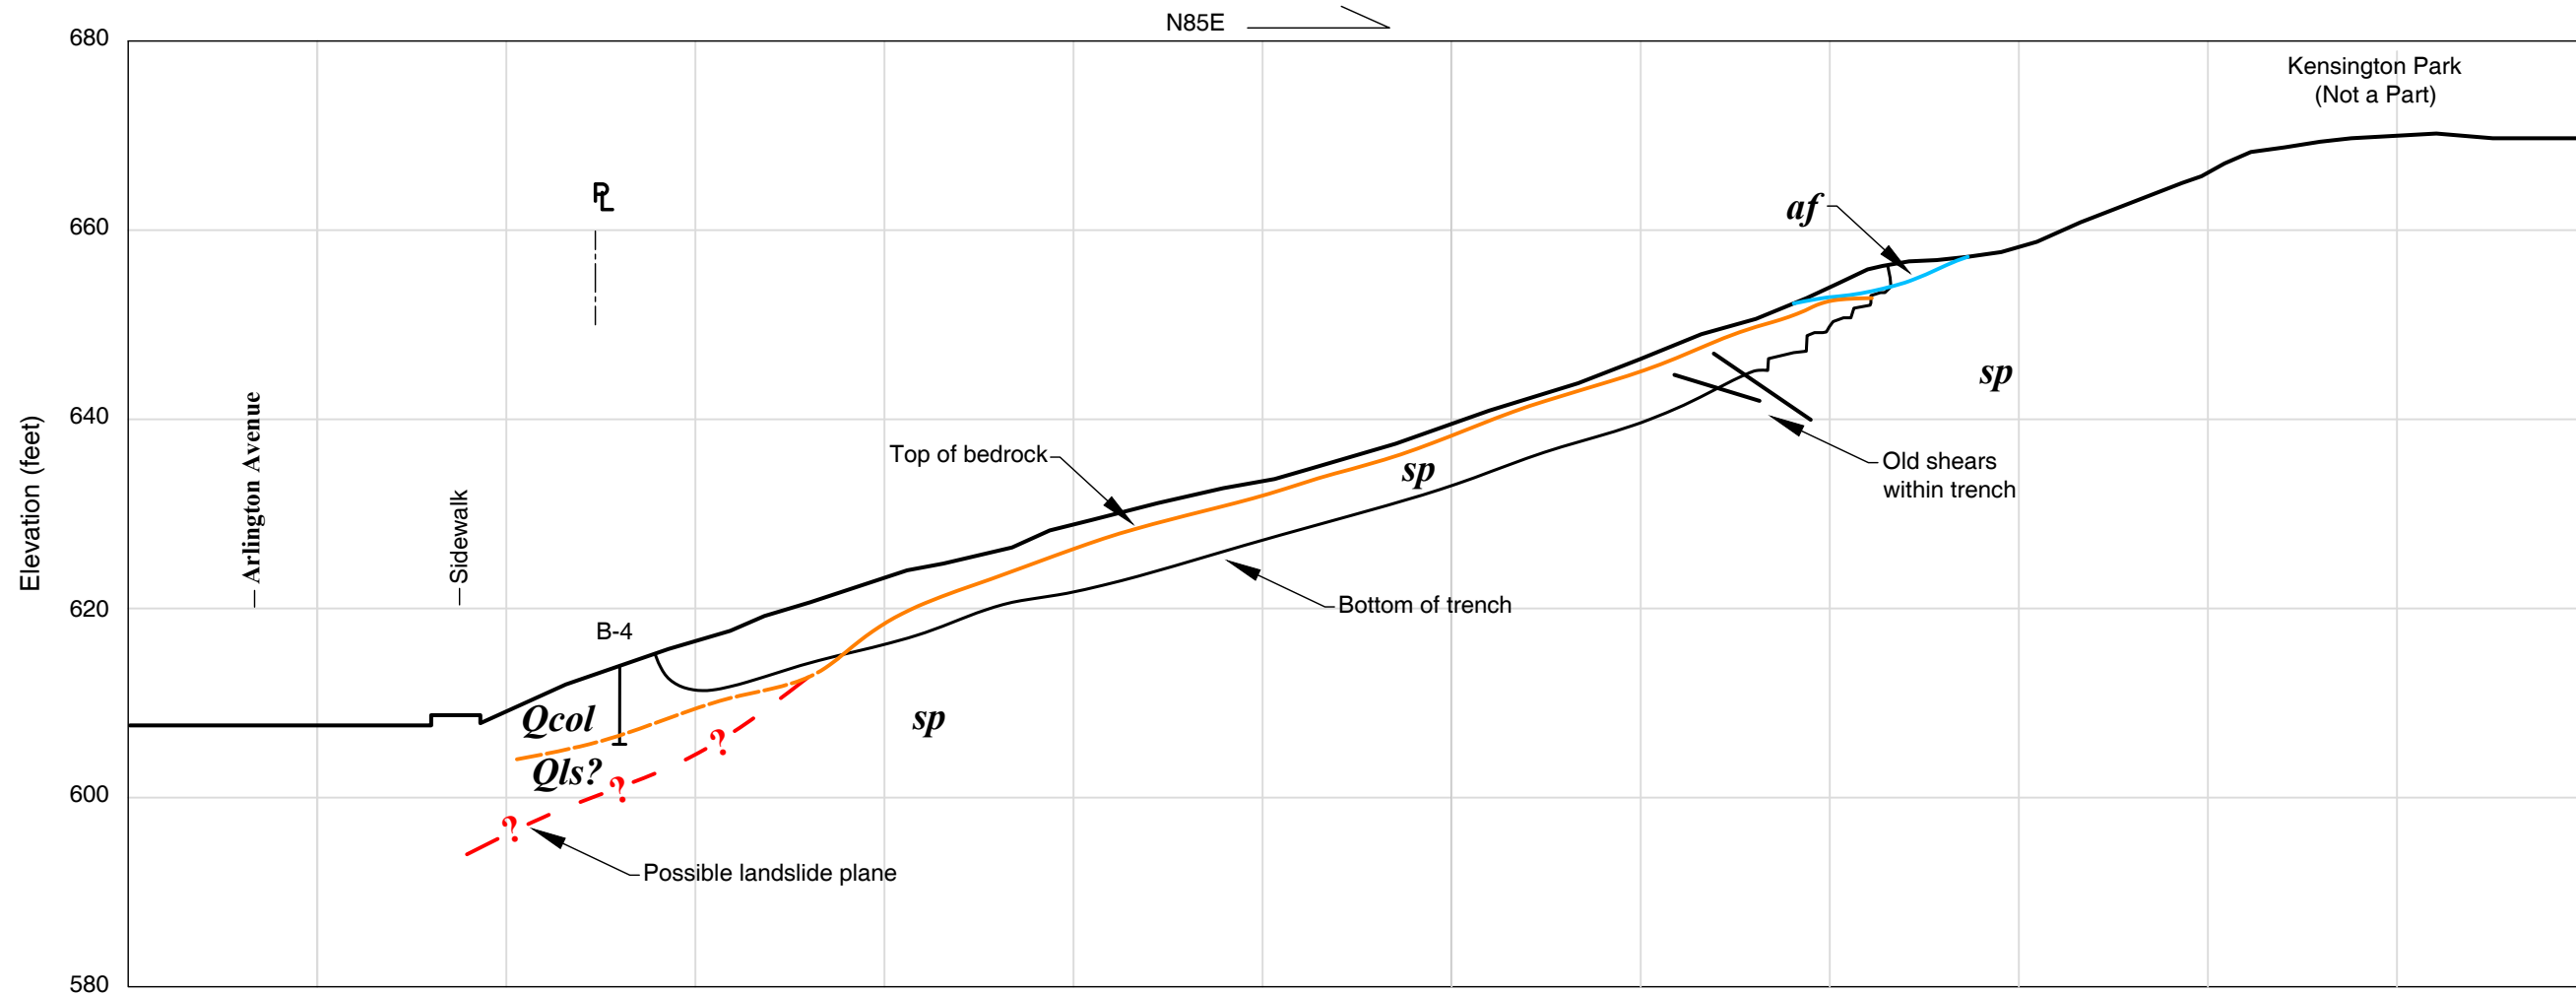
FIGURE **10**

No evidence of active faulting was identified within the limits of the fault trench excavated through the portion of the property slated for development. The exploratory borings logged to the north of the trench excavation confirm the consistency of the bedrock lithology underlying the site. Our interpretation of the subsurface geologic conditions is depicted in a geologic cross section that passes through the site from the top of slope to Arlington Avenue utilizing our collected surface data as shown on Figure 10.

We have identified a possible landslide in the lower portion of the slope near Arlington Avenue that, if present, would continue offsite under Arlington Avenue to the southwest. Evidence for the presence of this possible landslide is a drop in the top of the bedrock surface logged in the west end of the trench excavation that coincides with a thickening of the colluvial soils. It is our opinion that the risk of earthquake-induced landsliding to impact the proposed project is considered to be low provided our recommendations are incorporated into the design and construction of the proposed residence.
