# GEOTECHNICAL STUDIES AND FAULT HAZARD INVESTIGATION POLICE DEPARTMENT BUILDING SITE ARLINGTON AVENUE, APN: 572-040-011 KENSINGTON, CALIFORNIA

September 23, 2024  
3194-1A, L-33486

RE: Geotechnical Studies and Fault Hazard Investigation  
Police Department Building Site  
Arlington Avenue, APN: 572-040-011  
Kensington, California

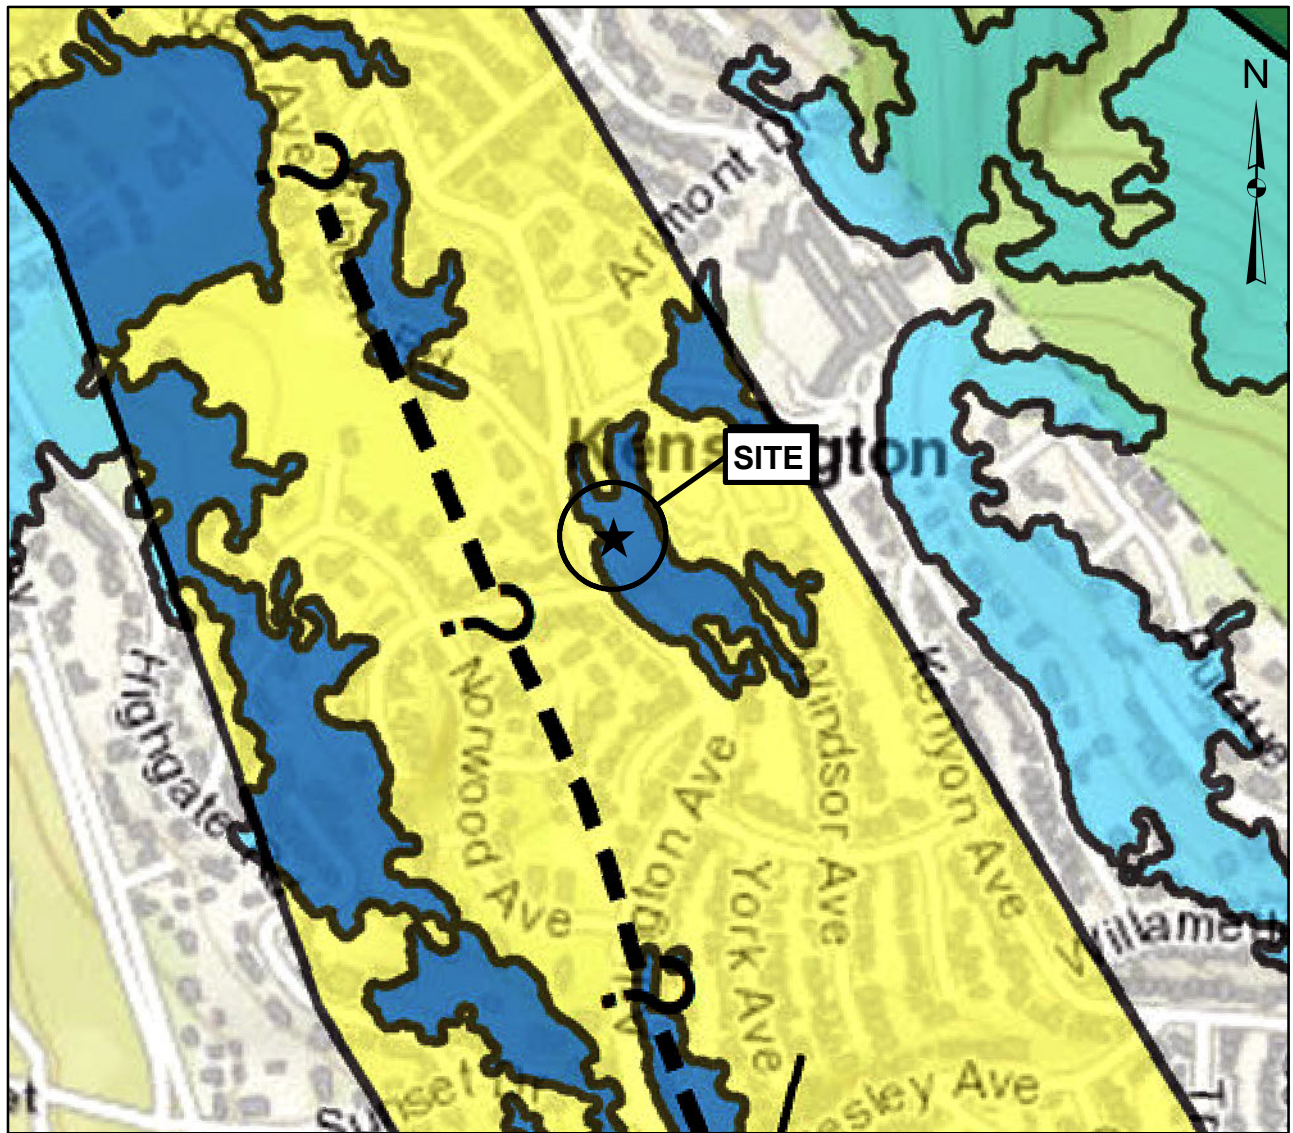
| PROJECT NO.<br><b>3194-1A</b> | DATE<br><b>September 2024</b> | <b>FIGURE 3</b> |

The site is located within the Alquist-Priolo Earthquake Fault Zone (APEFZ) established by the State of California for the seismically active Hayward fault as shown on Figure 3 (California Geological Survey, 1982). Therefore, a fault investigation conforming to the standards of the California Geologic Survey had to be performed to clear the proposed building area of the site. In addition, some concerns regarding slope stability at the site have been raised. The site is also included within a State of California Seismic Hazard Zone for Earthquake-Induced Landslides as shown on Figure 4 (California Geological Survey, 2024a). Our assessment of the site presented here follows general guidelines established by California Geologic Survey Special Publication 117A (2008). Therefore, fault evaluation and landslide assessment have been performed by Certified Engineering Geologist, Patrick Drumm, for EFGS.

The nearest active trace of the Hayward-Rodgers Creek fault is mapped approximately 300 feet downslope to the west of the project site (see Figure 3). Due to the close proximity, the project site and surrounding areas are within a State of California Earthquake Fault Zone for seismically active faults as shown on Figures 3 and 4. All of the active traces for the Hayward-Rodgers Creek fault zone are mapped downslope to the west of the site along the west side of Arlington Avenue (State Geologist, 1982; and Lienkaemper, 1992).

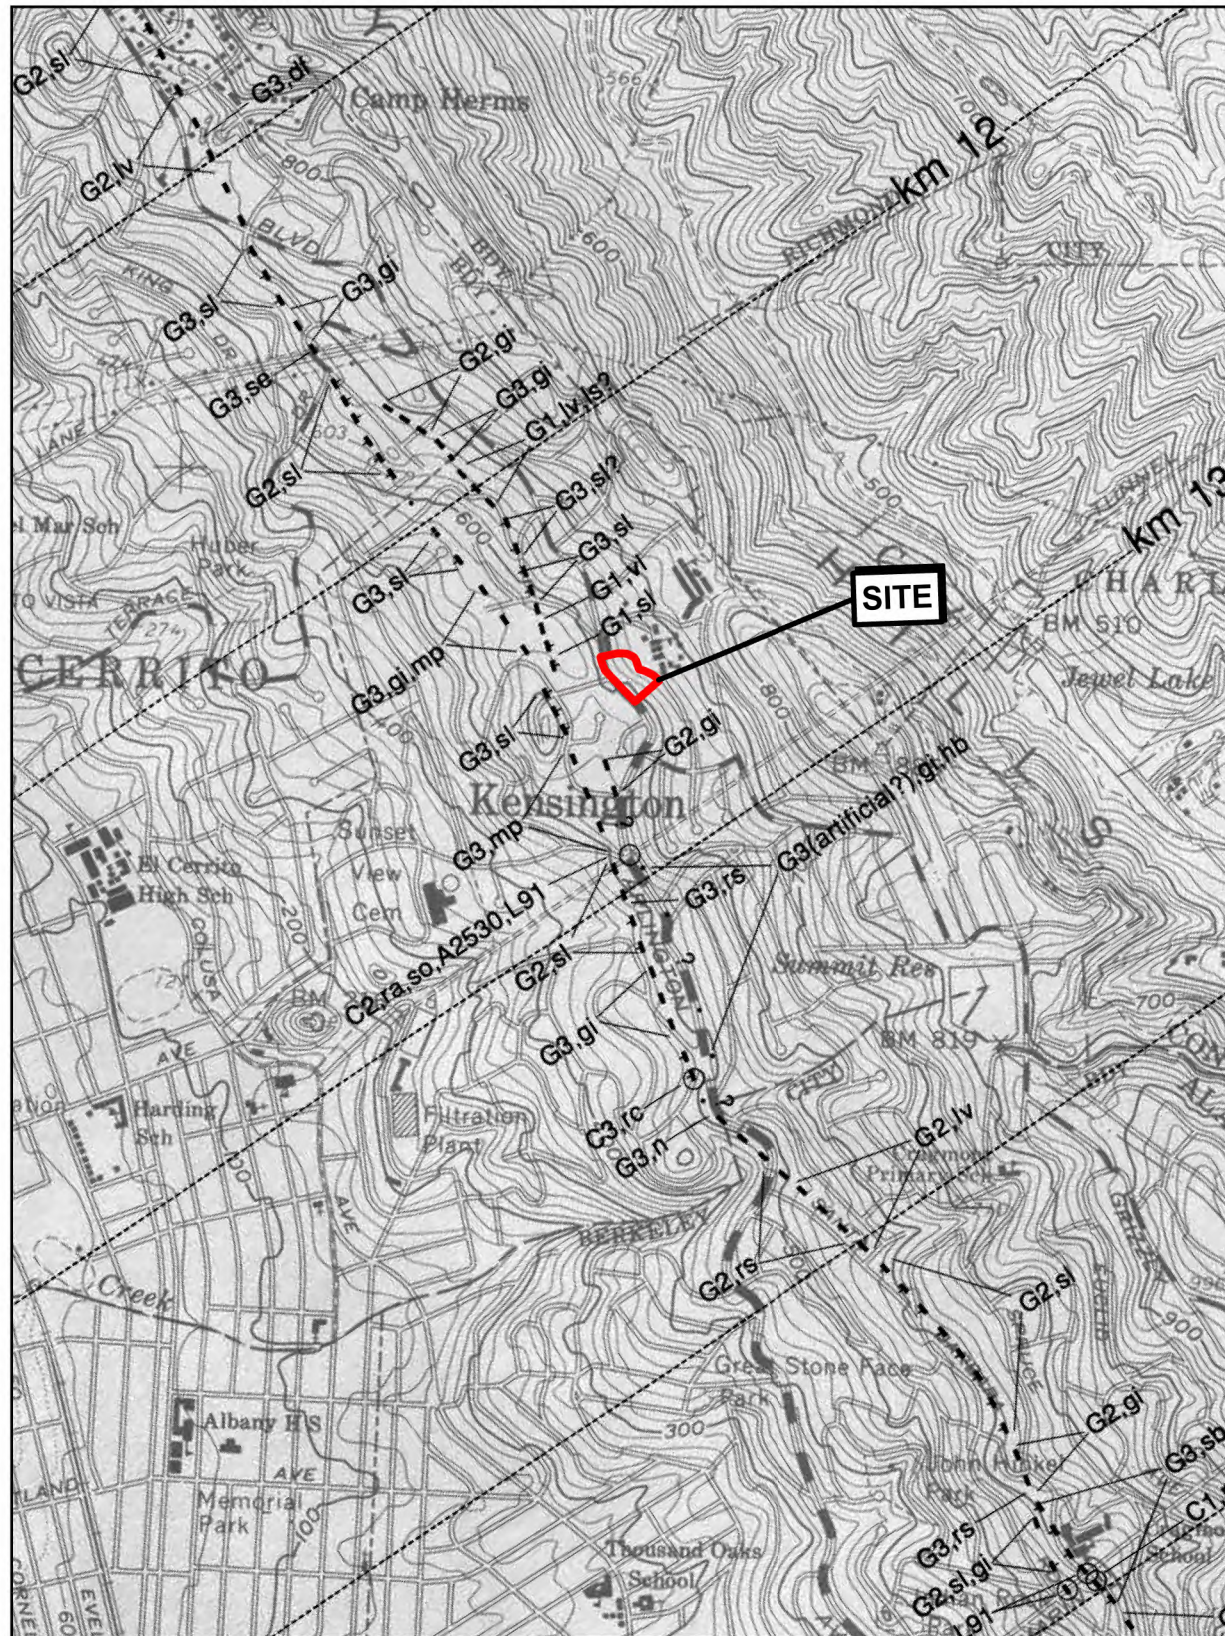
FIGURE **6**

Seismic activity within the northern Coast Ranges is generally associated with active faults belonging to the San Andreas system of faults, including major active structures both east and west of the site, as shown on the Regional Active Fault Map of Figure 6. According to published maps, the project site is within close proximity to mapped traces of the northwest-southeast-trending Hayward-Rodgers Creek fault zone (Lienkaemper, 1992; Radbruch, 1967; and Radbruch-Hall, 1974). The site is included within an Alquist-Priolo Earthquake Fault Zone (APEFZ) for the Hayward-Rodgers Creek fault, as established by the State of California for seismically active faults and shown on Figure 3 (California Geological Survey, 1982; and Hart and Bryant, 1997).

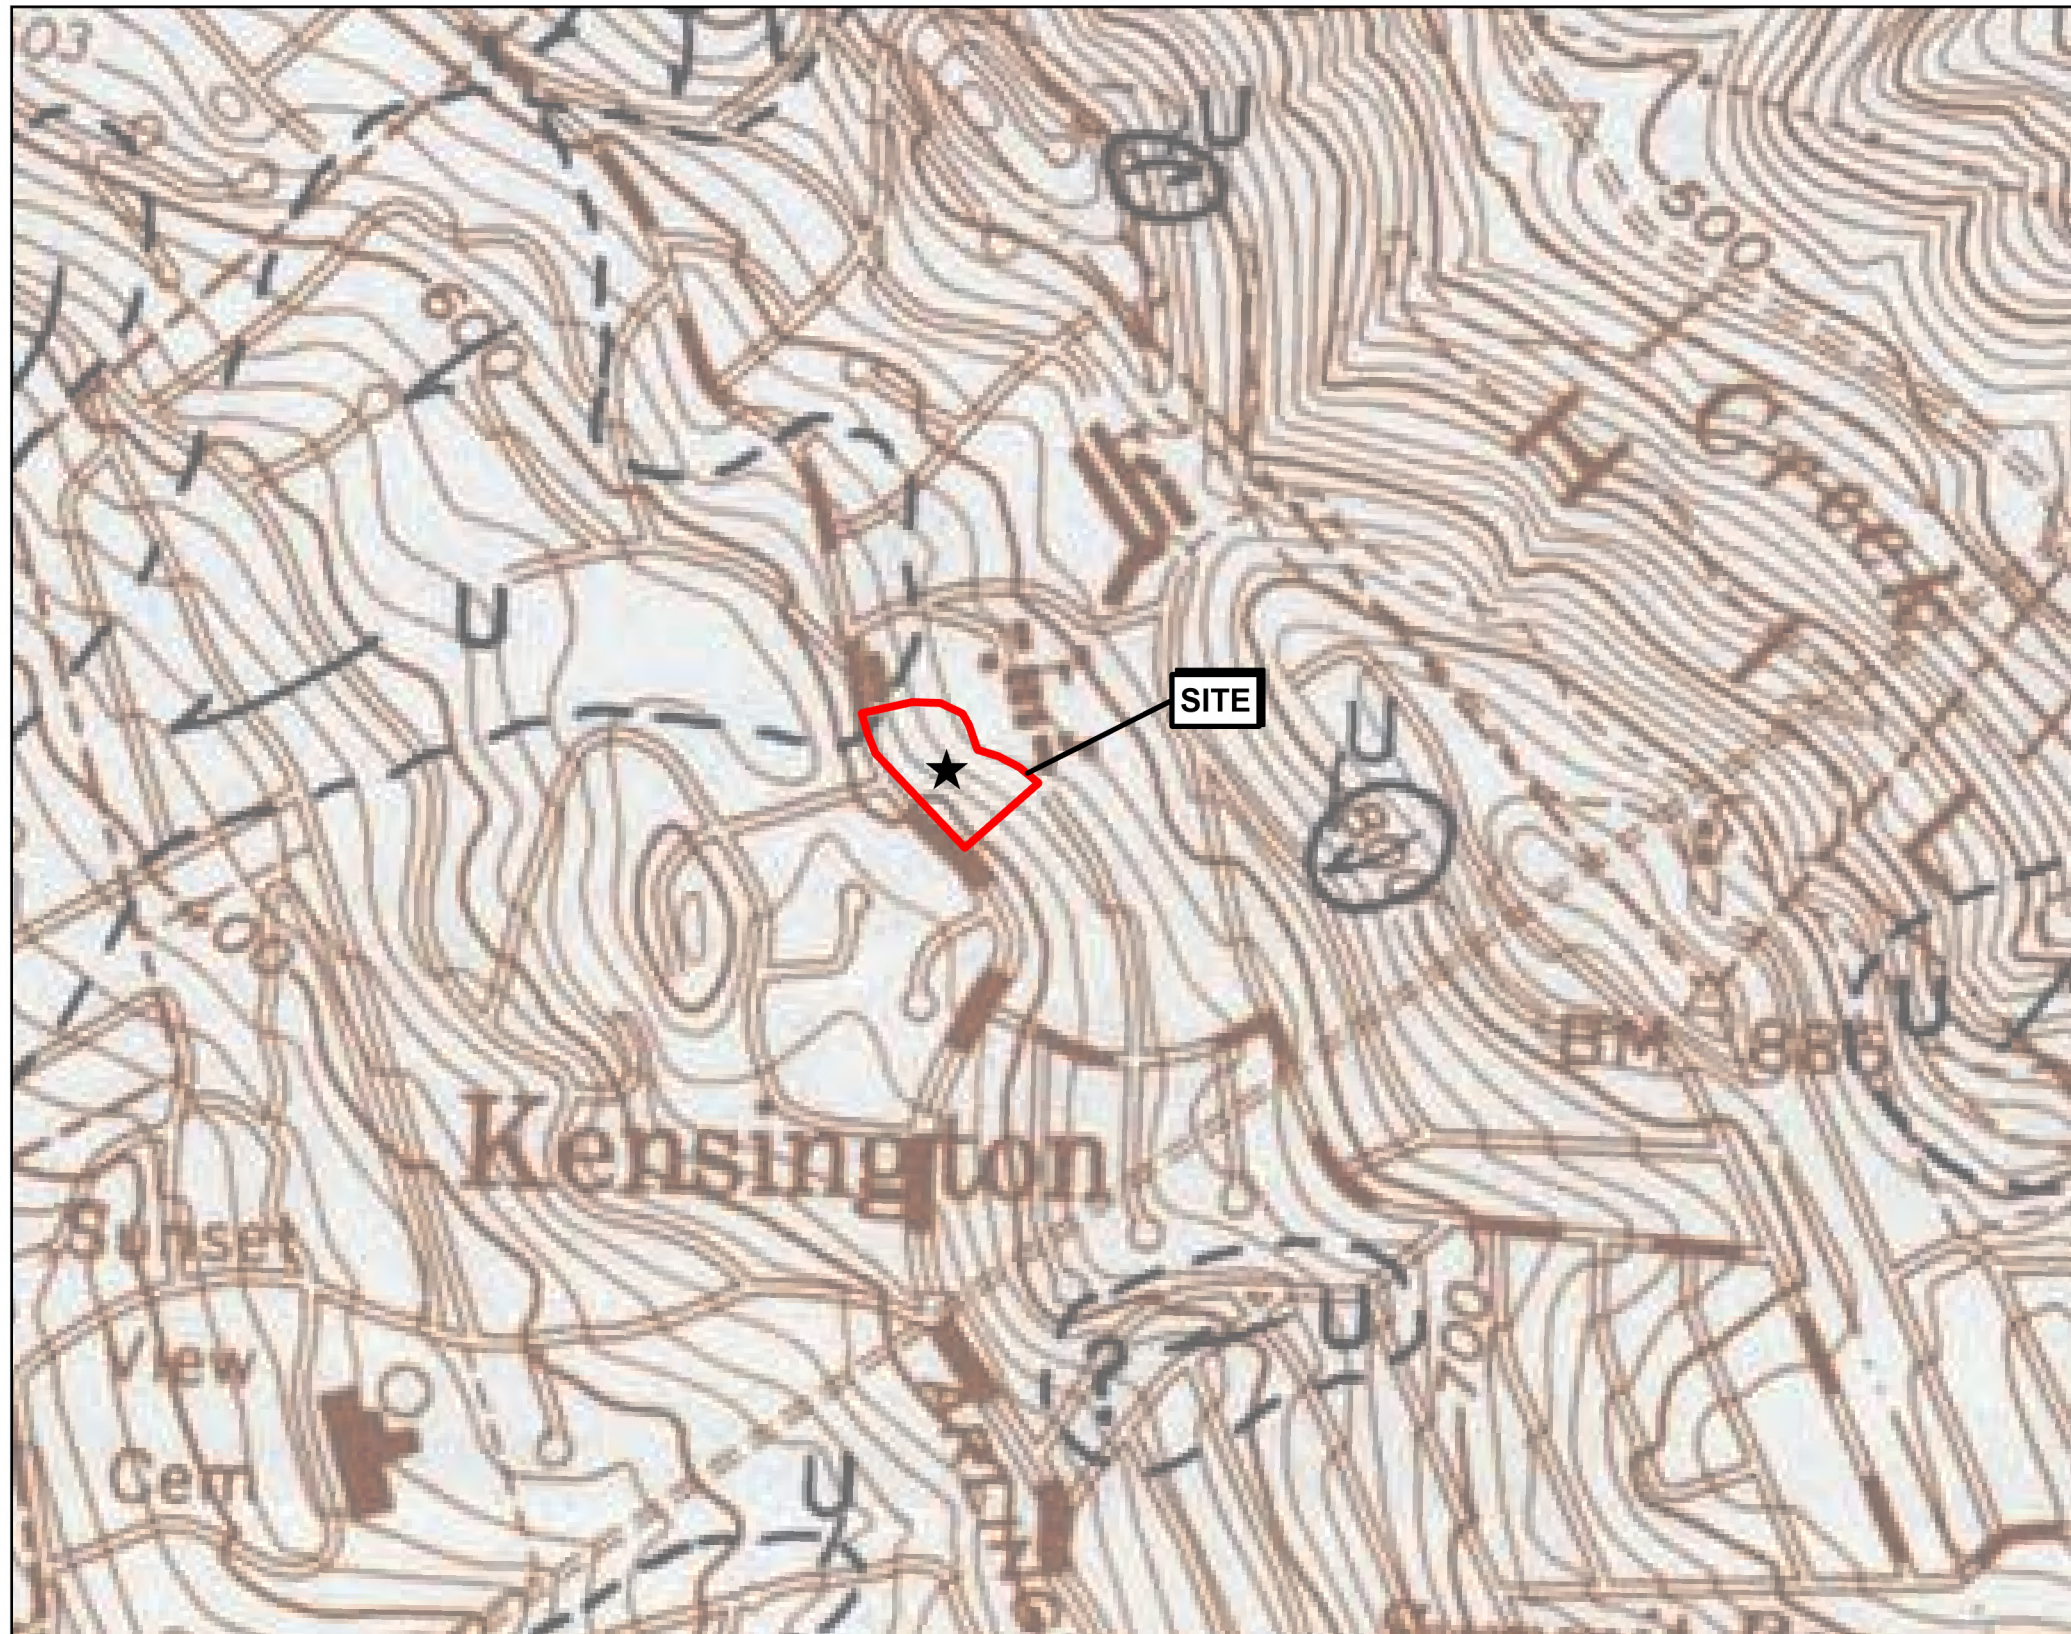
| RECENTLY ACTIVE TRACES OF THE HAYWARD FAULT | | |
|---|---|---|
| PROJECT NO.<br><b>3194-1A</b> | DATE<br><b>September 2024</b> | <b>FIGURE 7</b> |

Comparatively, a fault map prepared by the U.S. Geological Survey for recently active traces along the Hayward-Rodgers Creek fault shows one to two fault traces located downslope to the southwest of the site as shown on Figure 7. The closest fault trace is approximately 400 feet to the west (Lienkaemper, 1992). This map combines site-specific fault exploration data performed by private consultants for nearby properties with geologic interpretations of geomorphic characteristics consistent with active fault-related features. Not all of the possible fault traces associated with the Hayward-Rodgers Creek fault zone are included on this map.
